t: 02079364566

[info@emphasisinventories.co.uk](mailto:info@emphasisinventories.co.uk)

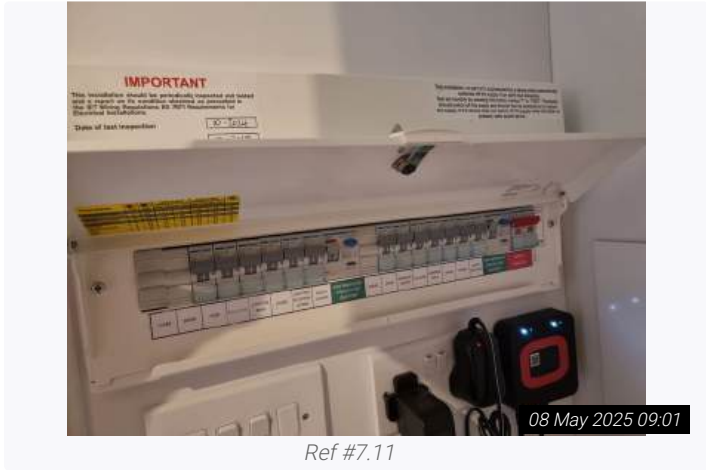
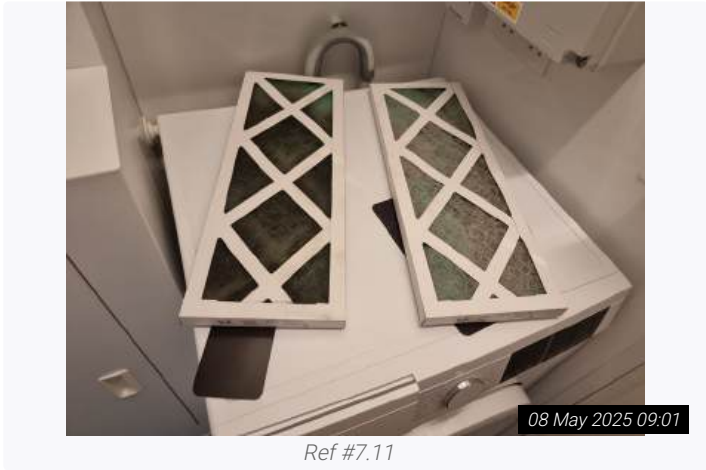
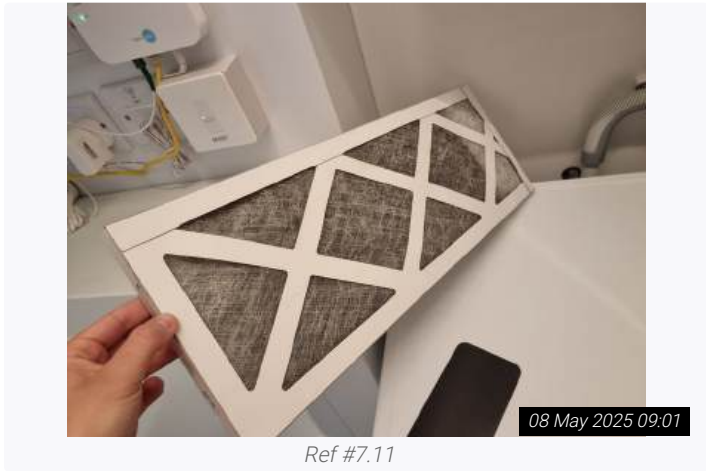
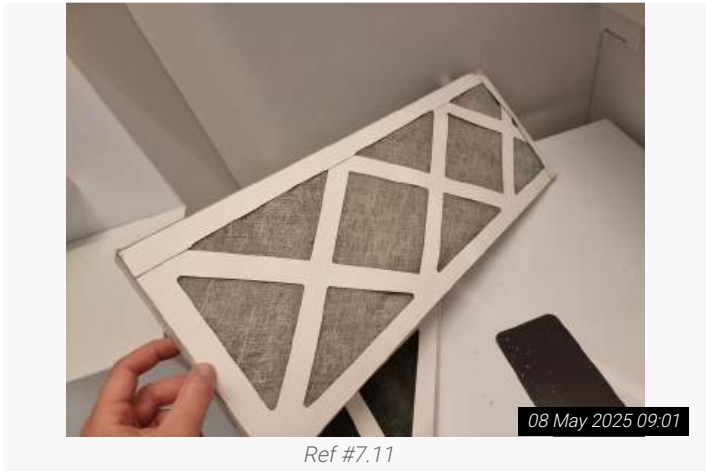
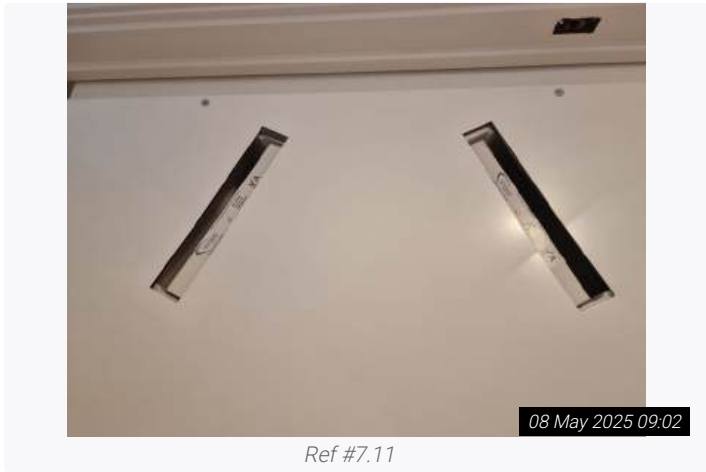
7. Entrance Hall (Cont.)

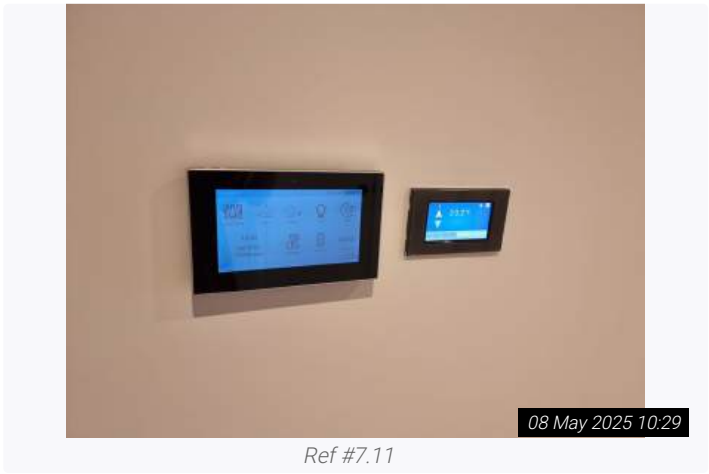
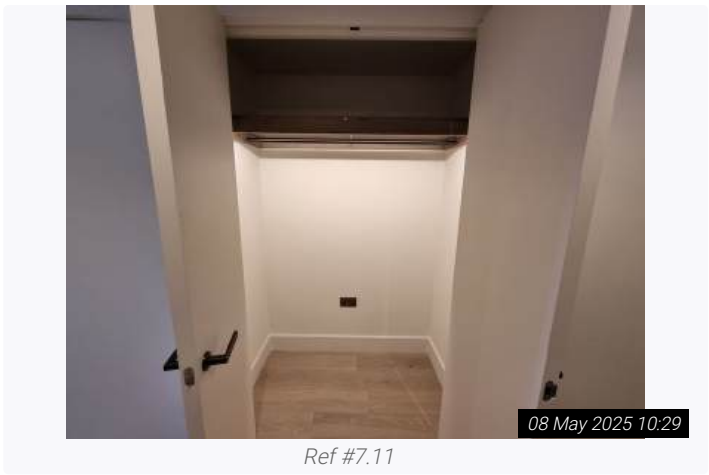
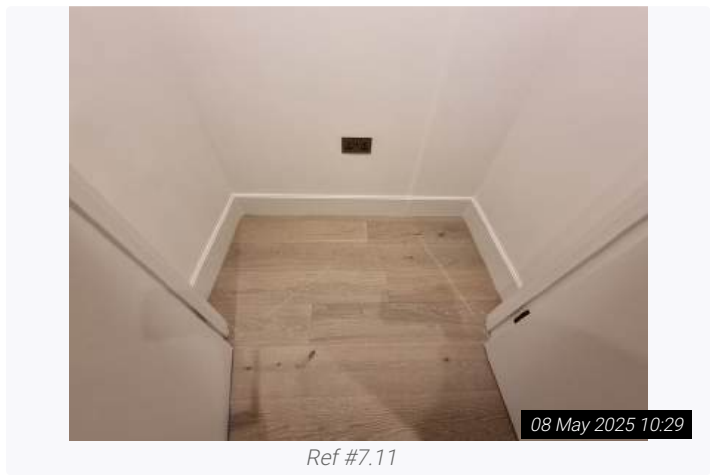
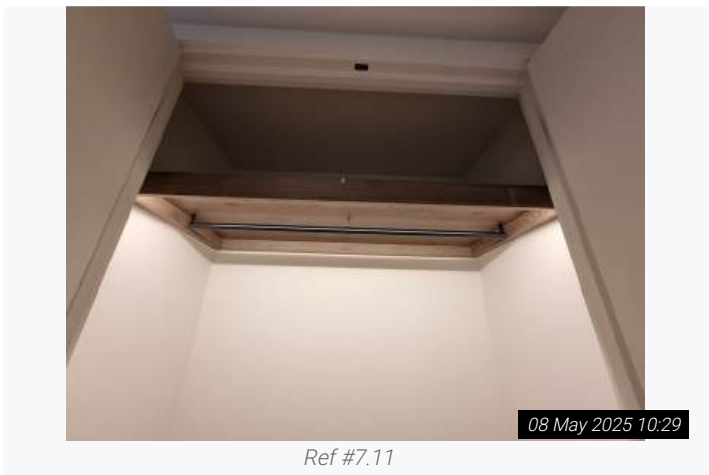
7. Entrance Hall (Cont.)

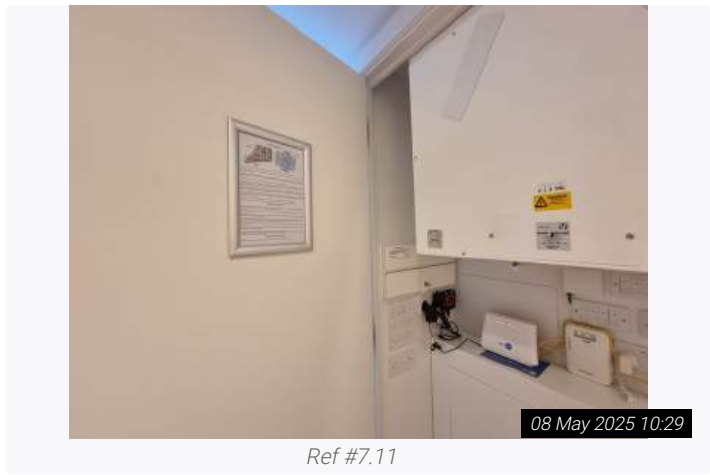
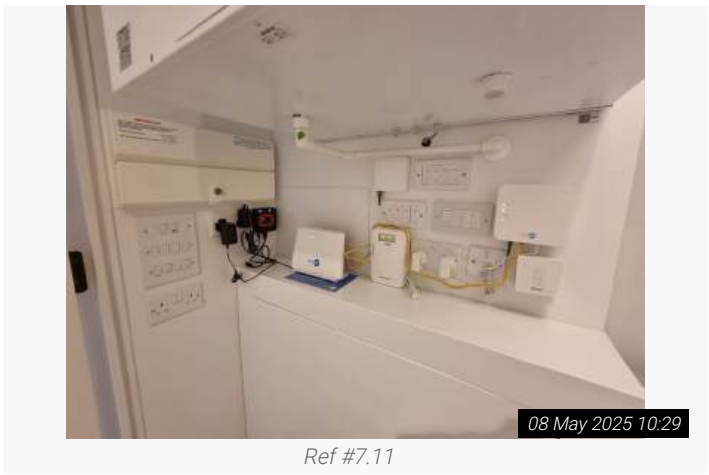
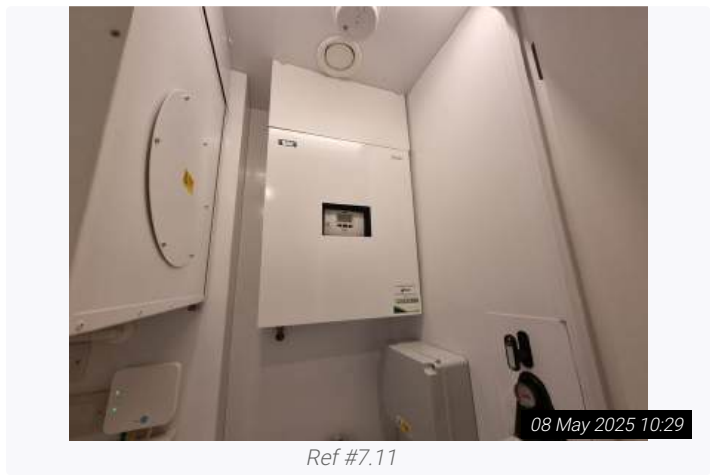
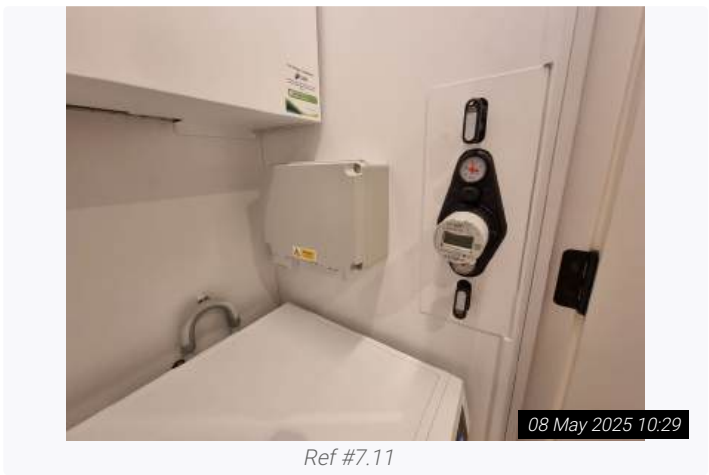
| Ref | Name | Description | Condition |

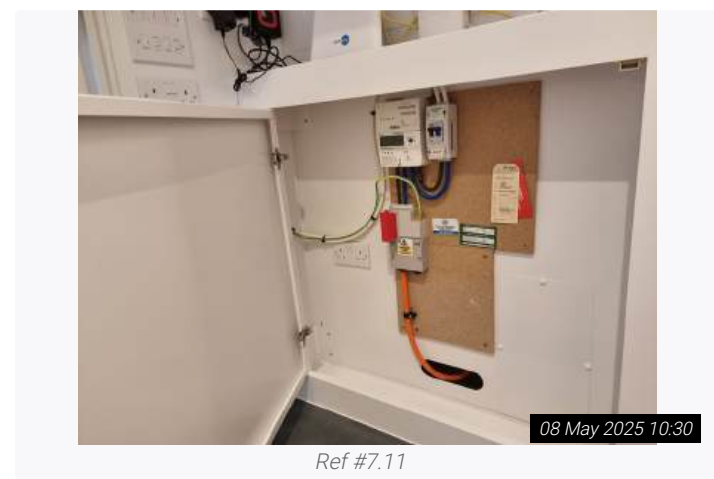
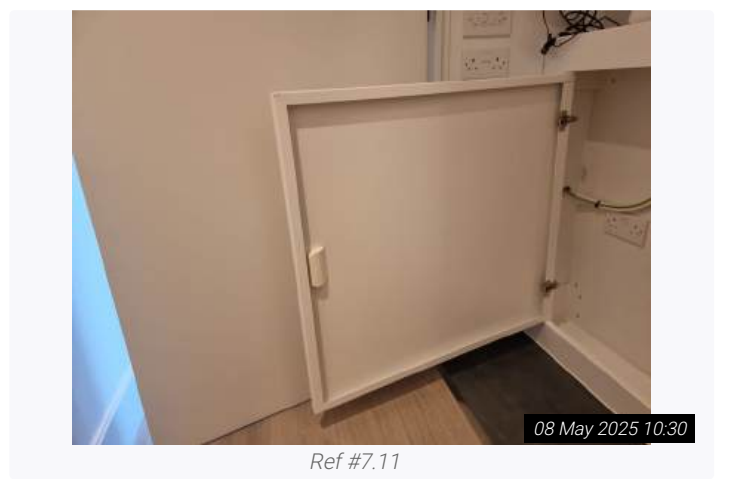
7. Entrance Hall (Cont.)

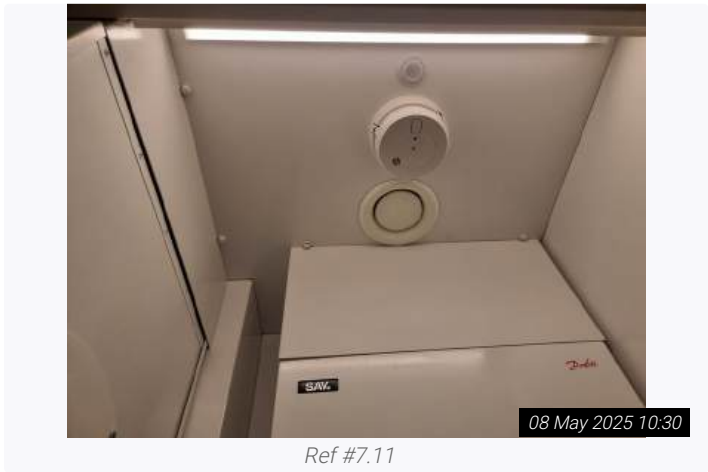
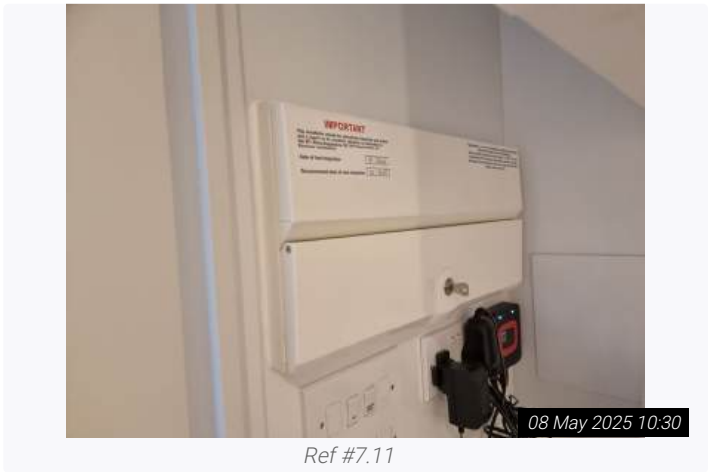
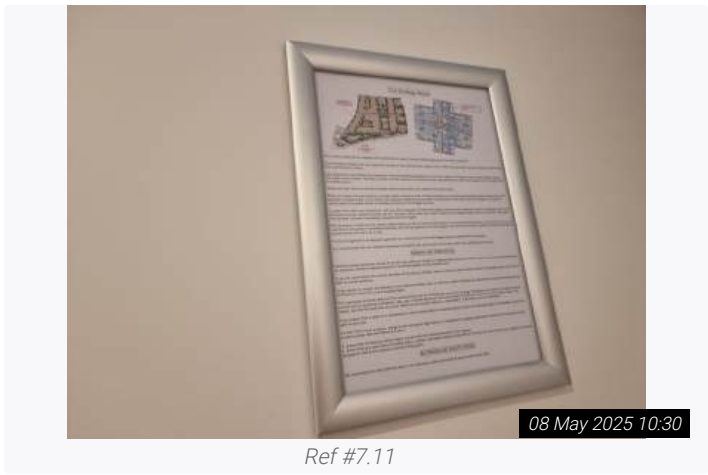
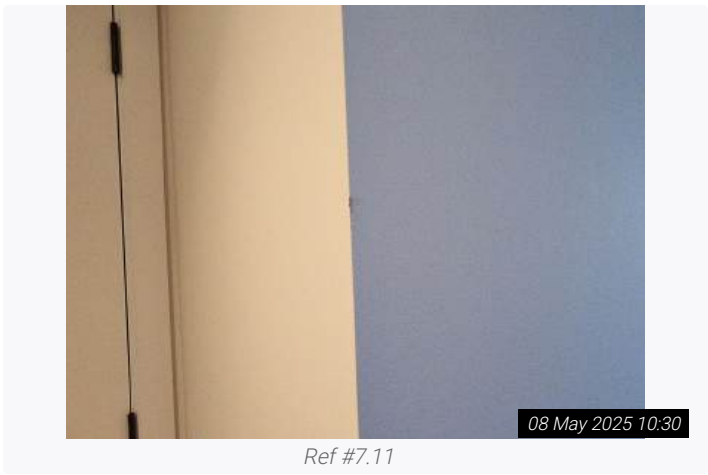
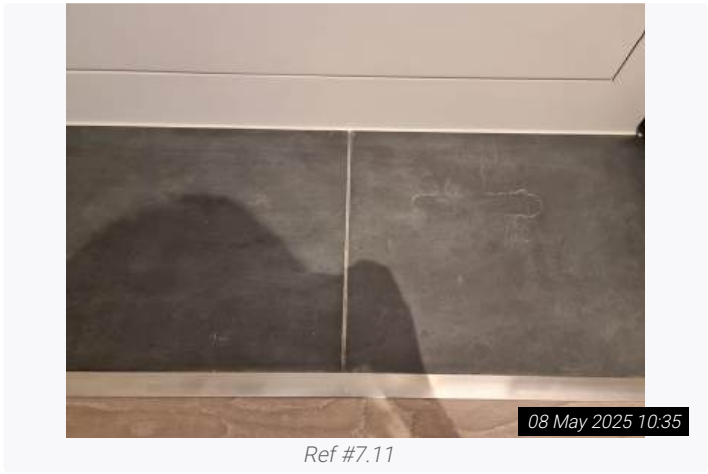
7. Entrance Hall (Cont.)

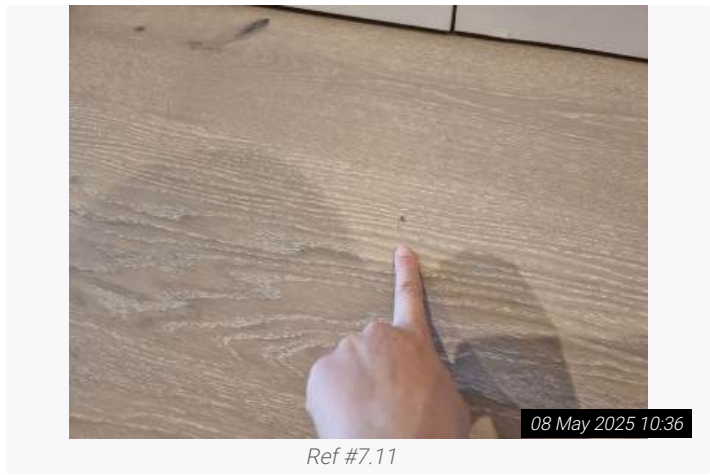
| Ref | Name | Description | Condition |

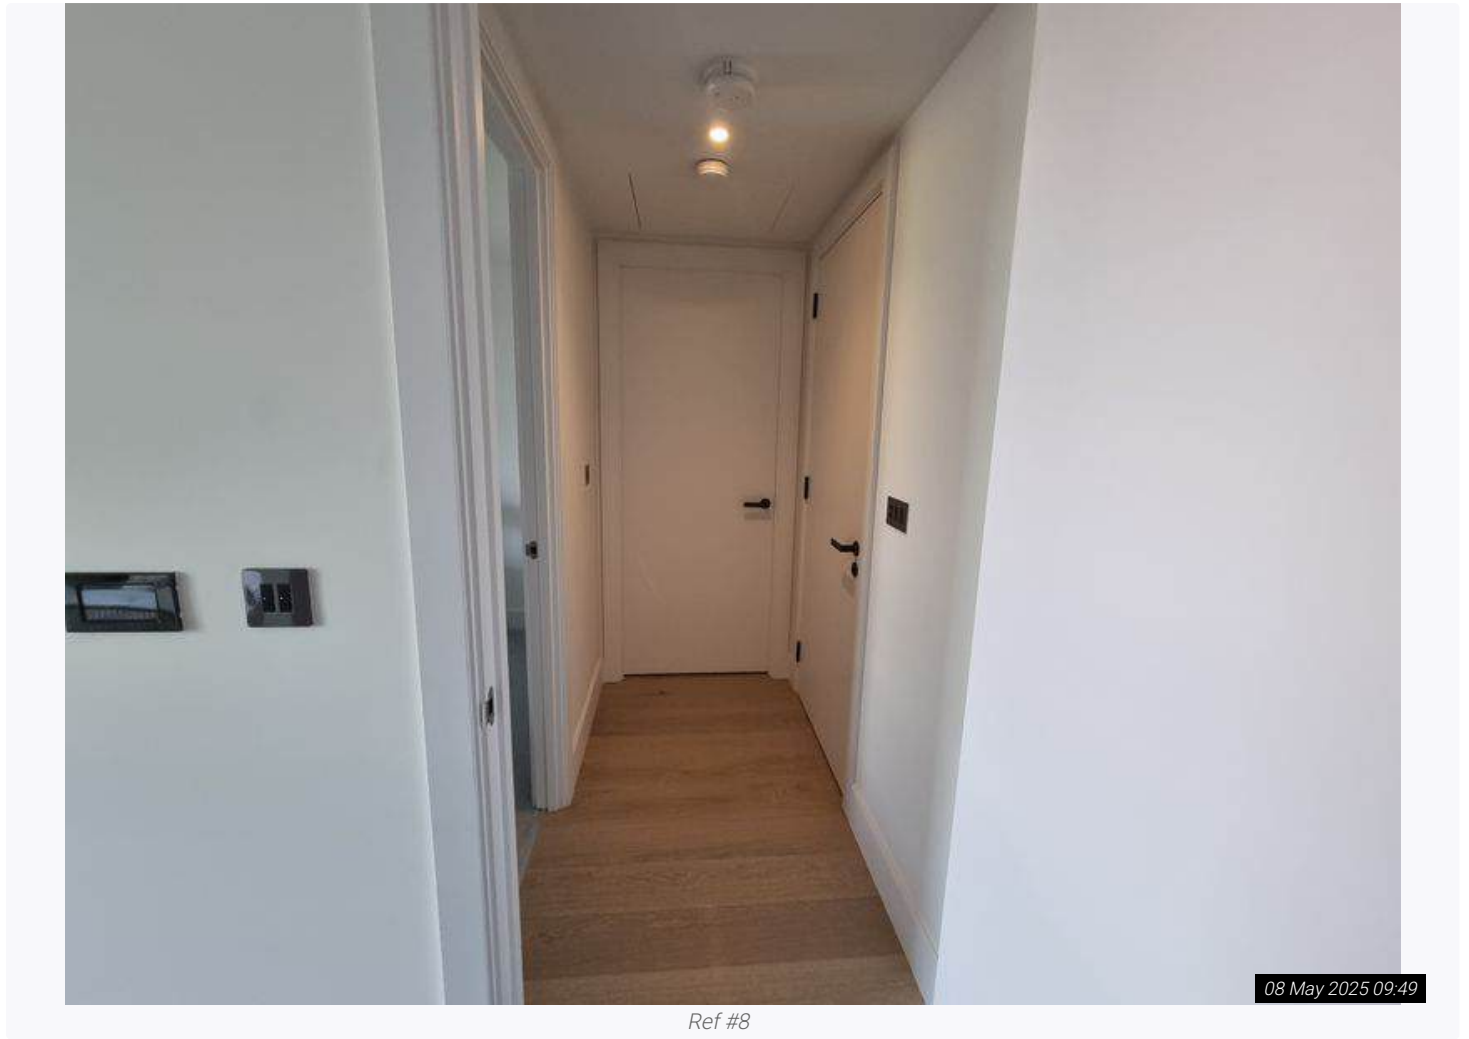
| Ref | Name | Description | Condition |

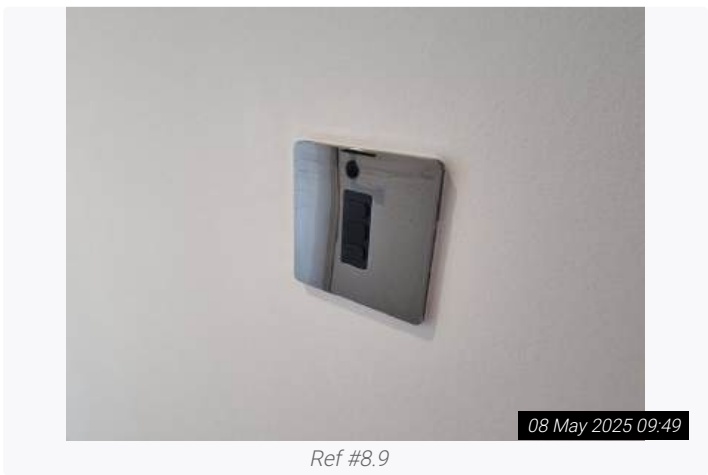
8. Inner Hallway (Cont.)

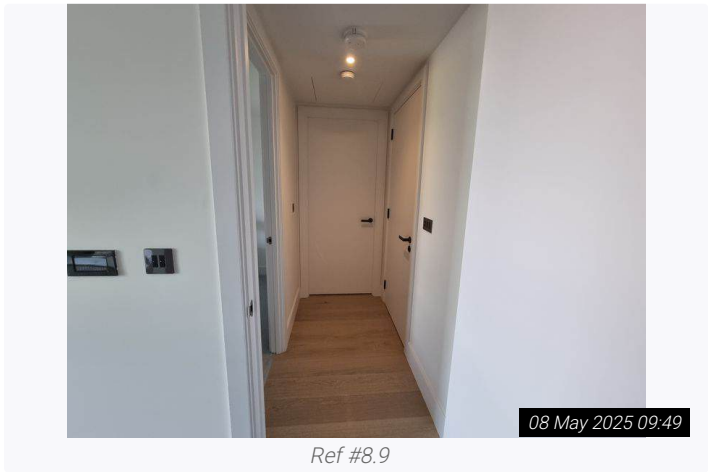
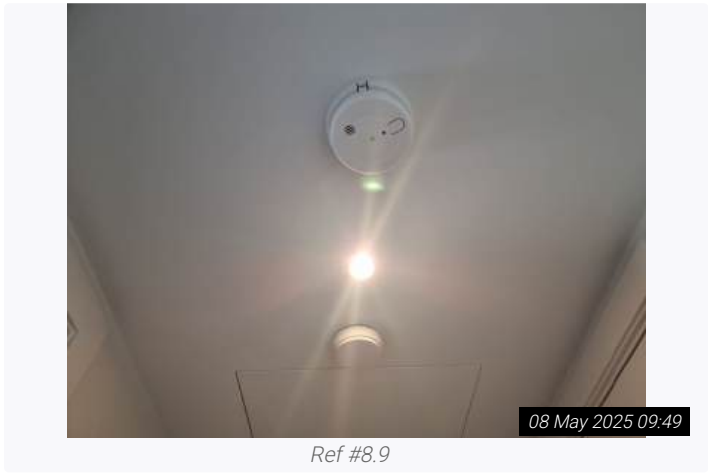
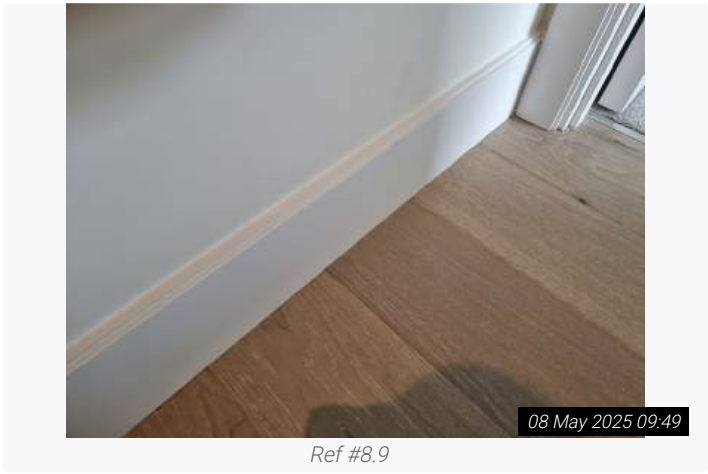
8. Inner Hallway (Cont.)

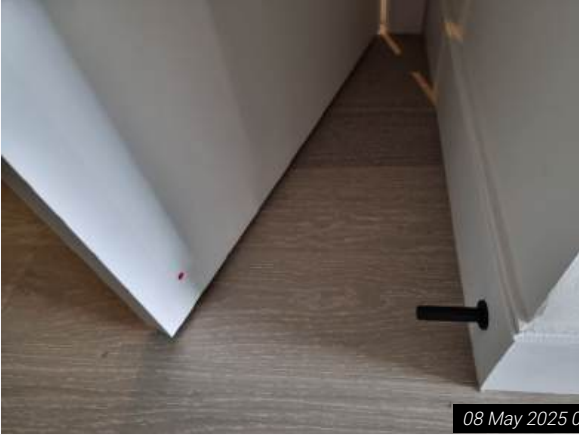
| Ref | Name | Description | Condition |
|---|---|---|---|
| <div><div><p>Ref #8.9</p></div><div><p>Ref #8.9</p></div></div> | | | |

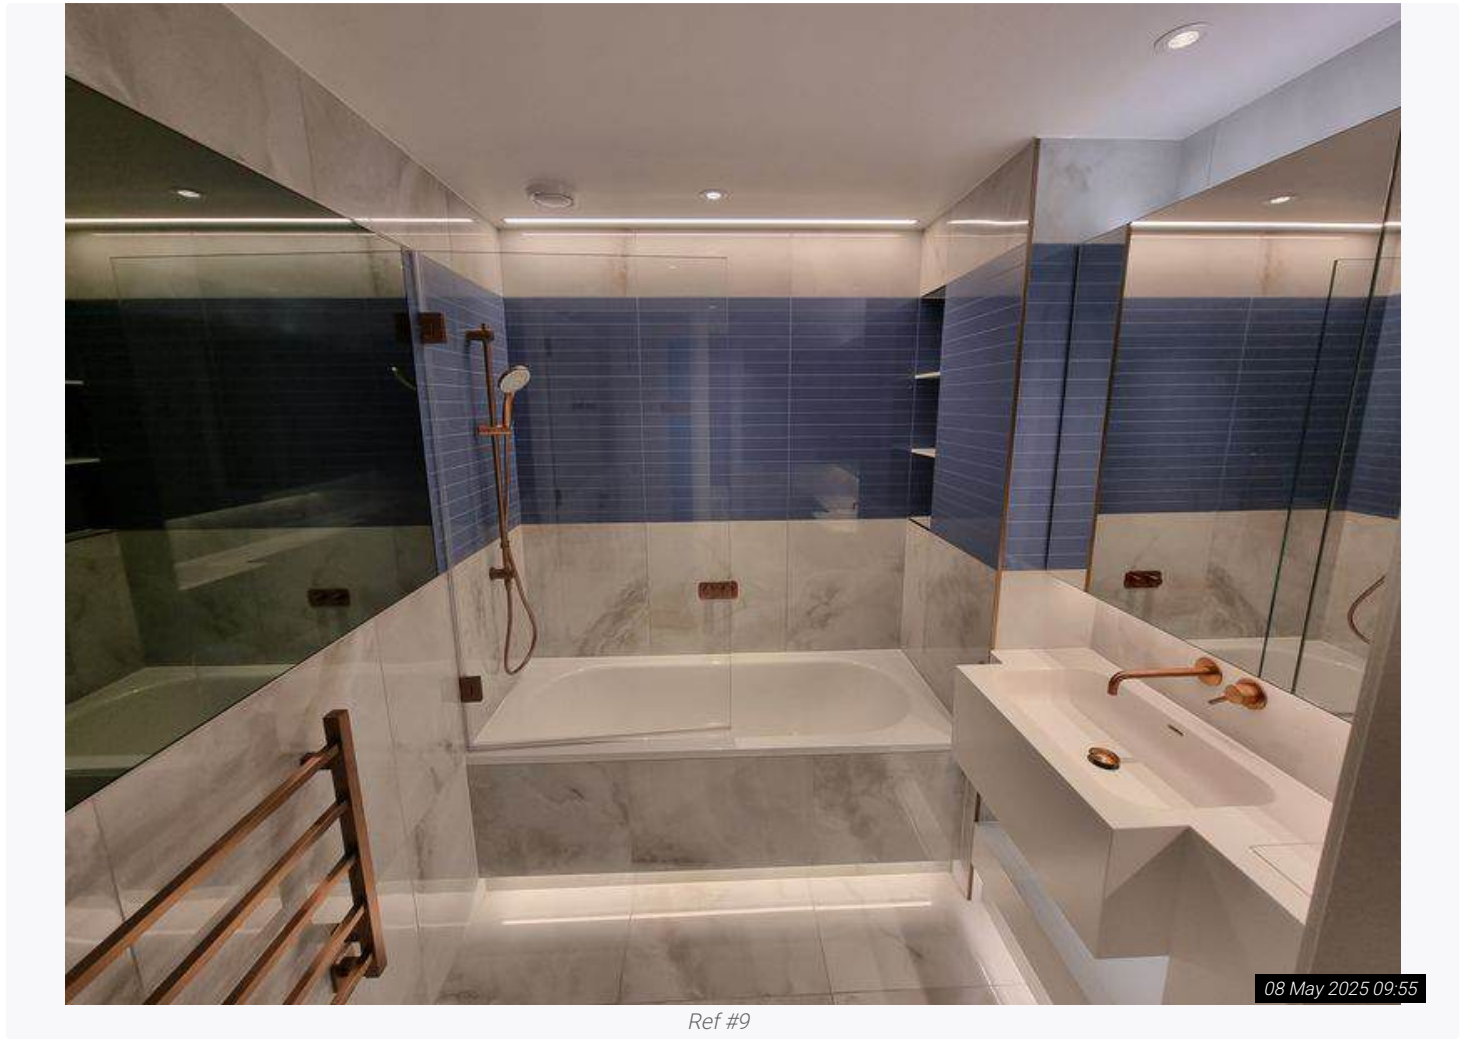
| Ref | Name | Description | Condition |

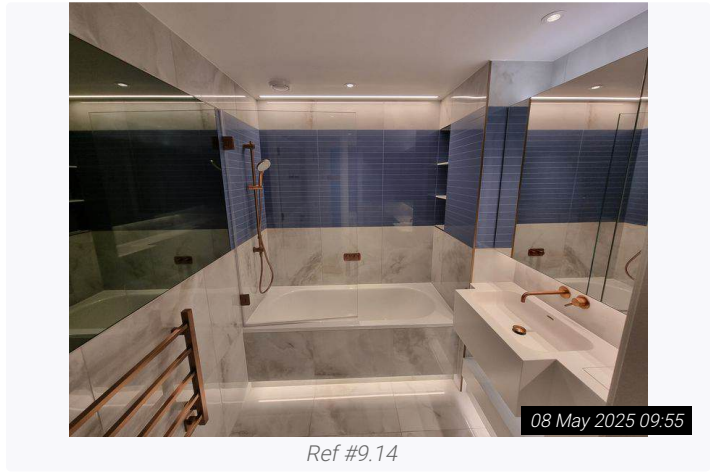
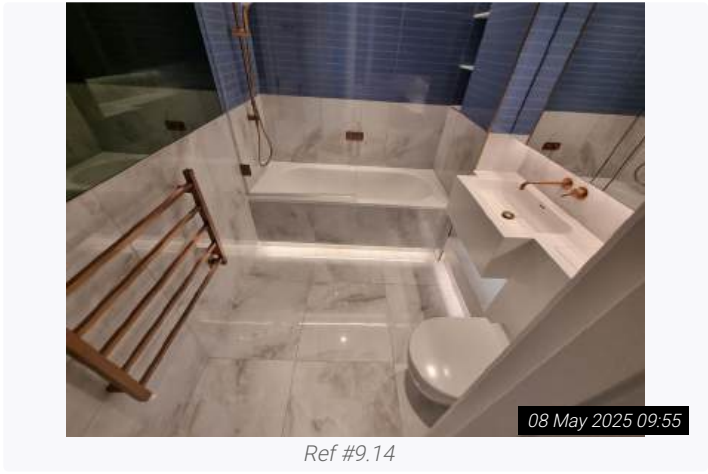
| Ref | Name | Description | Condition |
|---|---|---|---|
| 9.14 | Additional Photos | | |

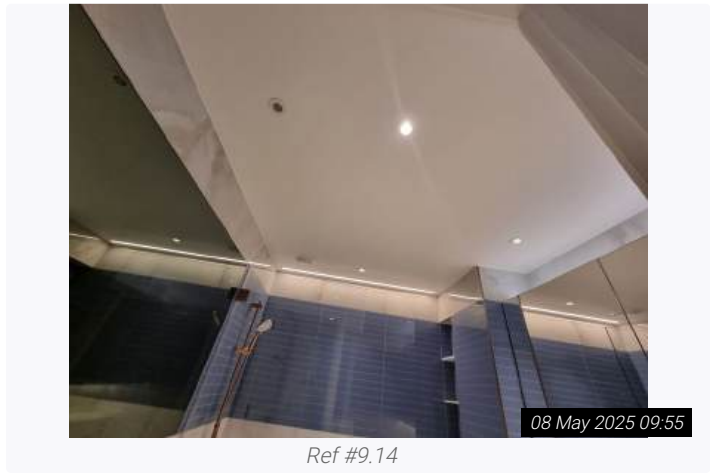
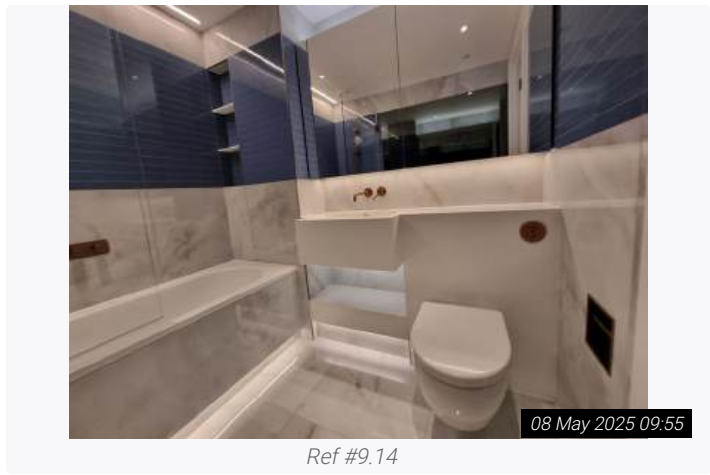
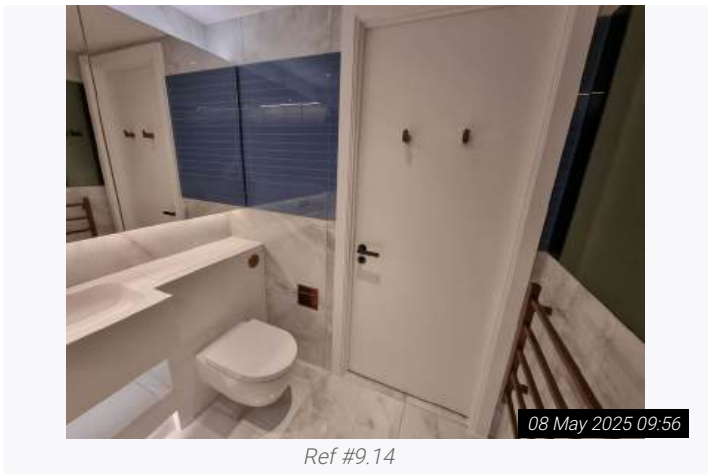
| Ref | Name | Description | Condition |

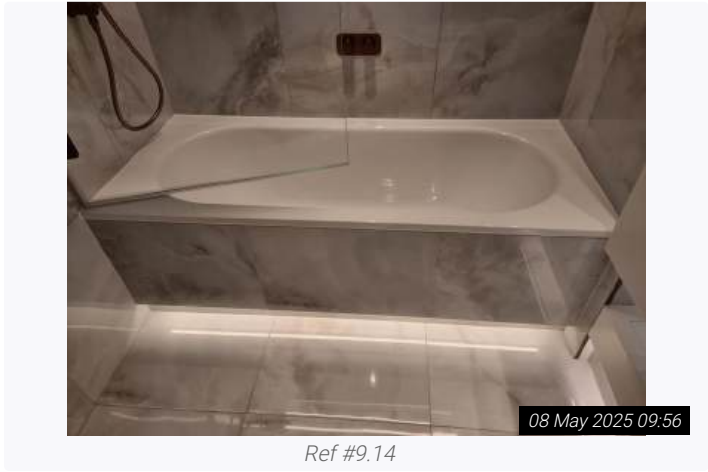
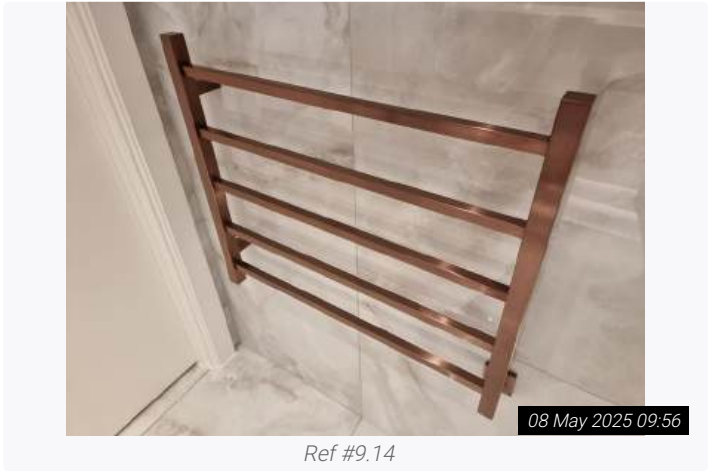
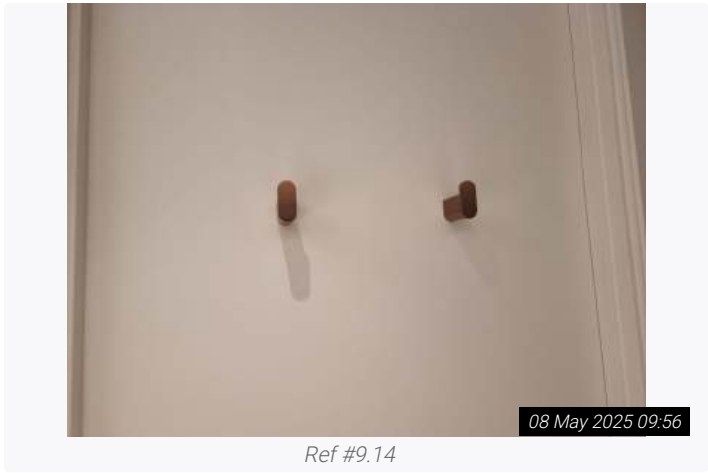
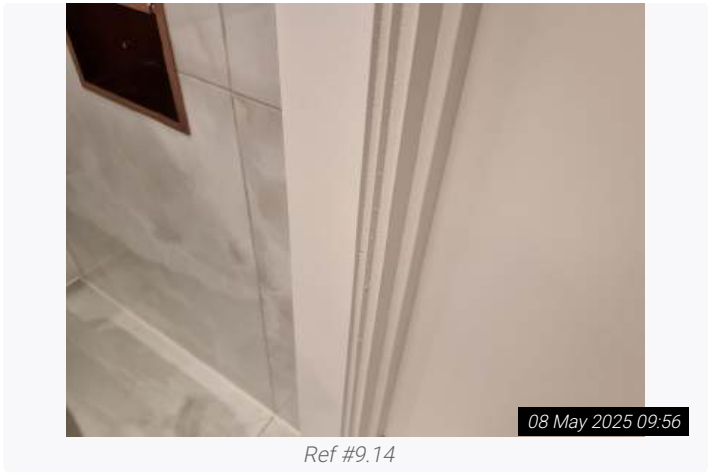
| Ref | Name | Description | Condition |

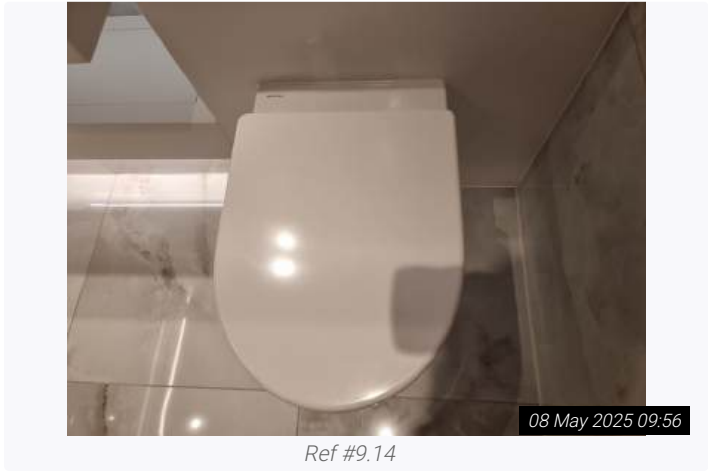
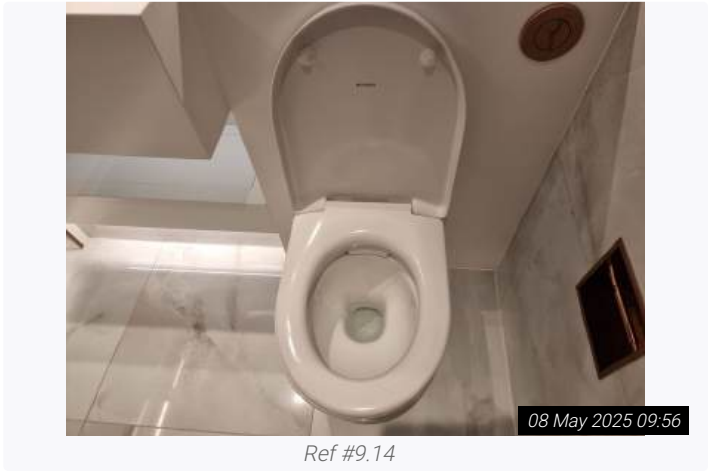
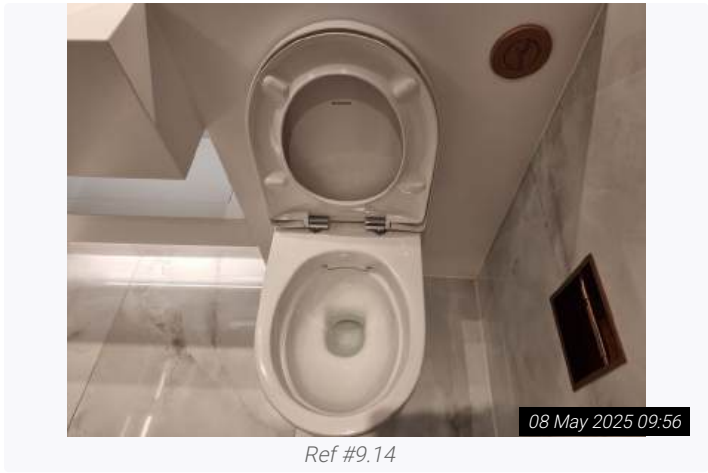
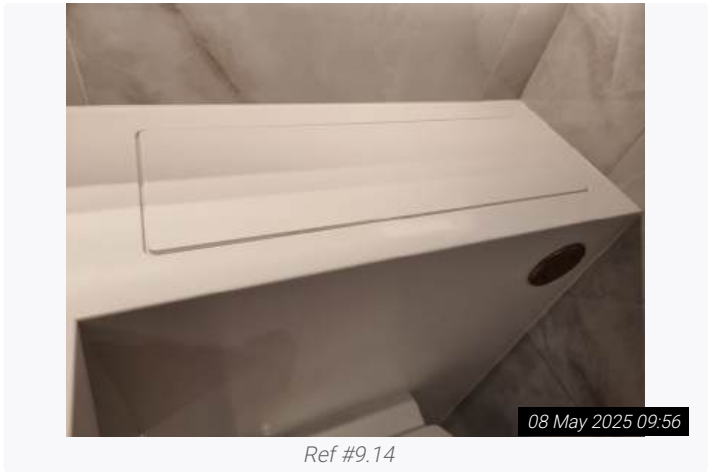
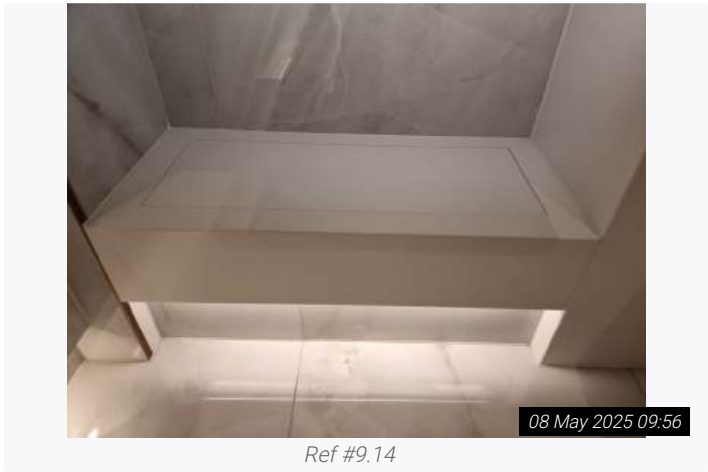
| Ref | Name | Description | Condition |

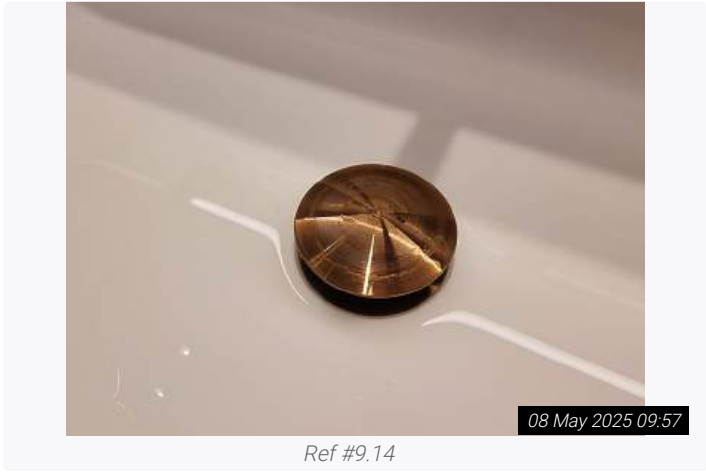
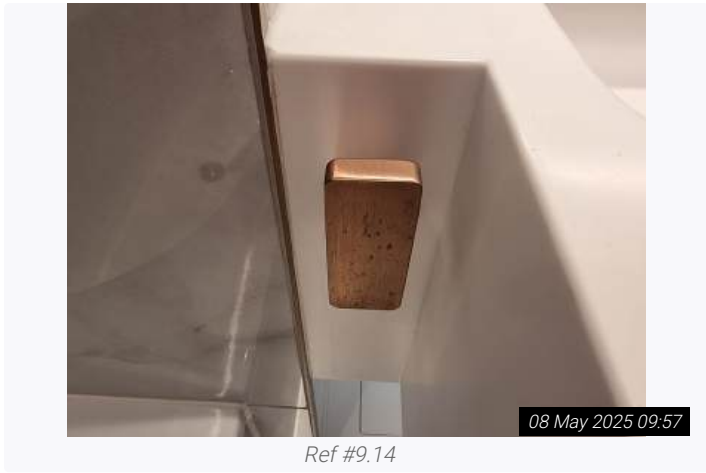
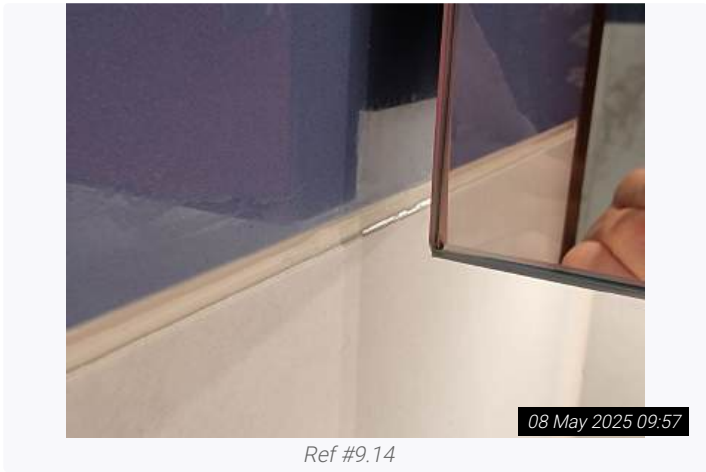
| Ref | Name | Description | Condition |

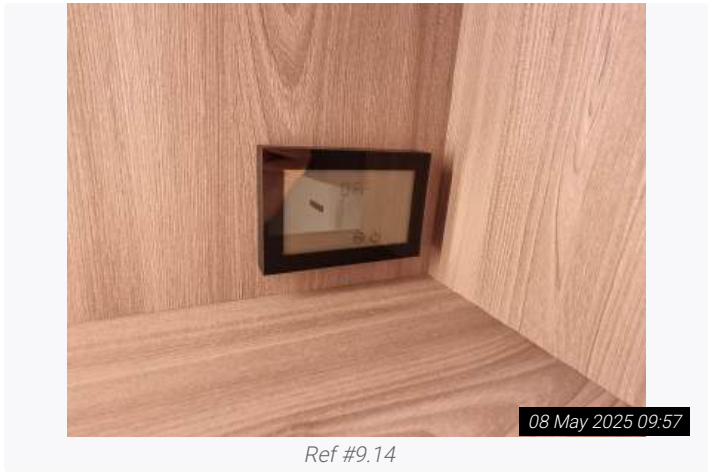
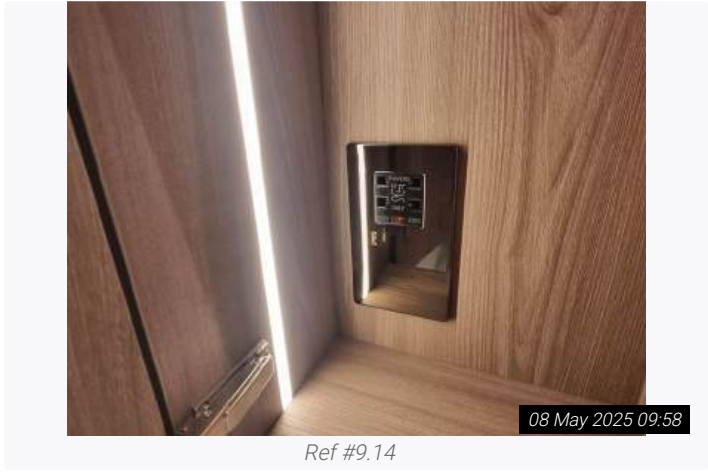
| Ref | Name | Description | Condition |

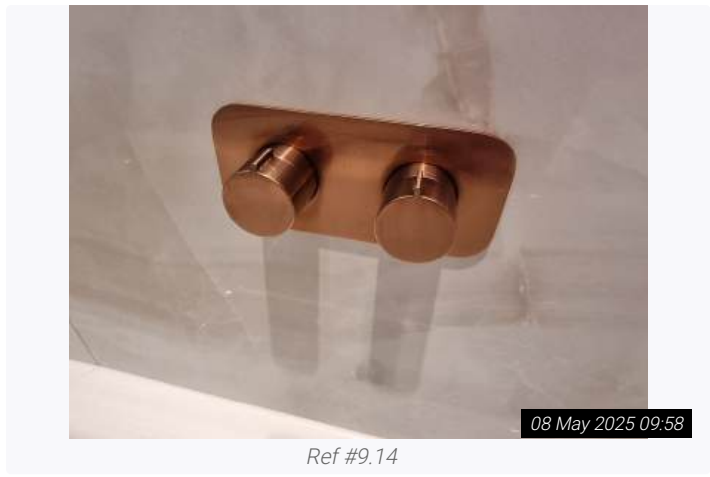
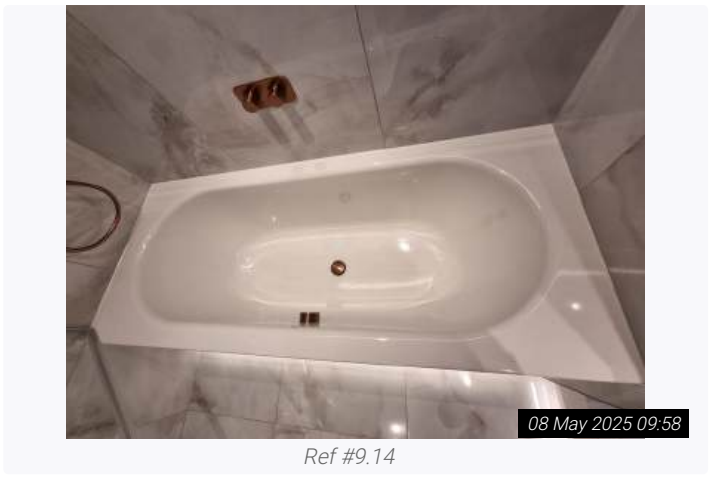
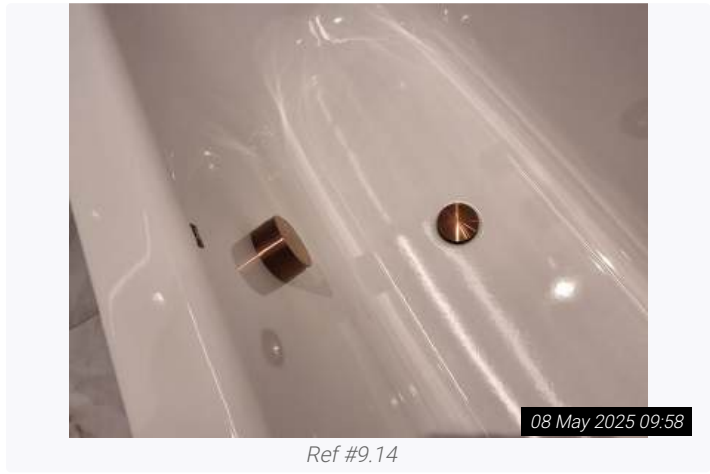
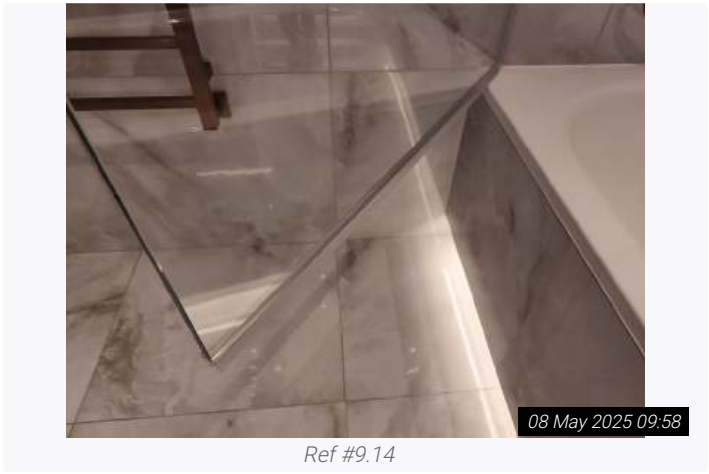
| Ref | Name | Description | Condition |

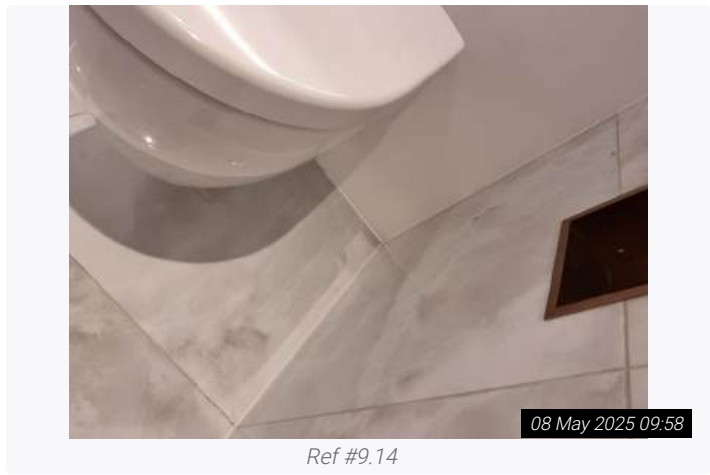
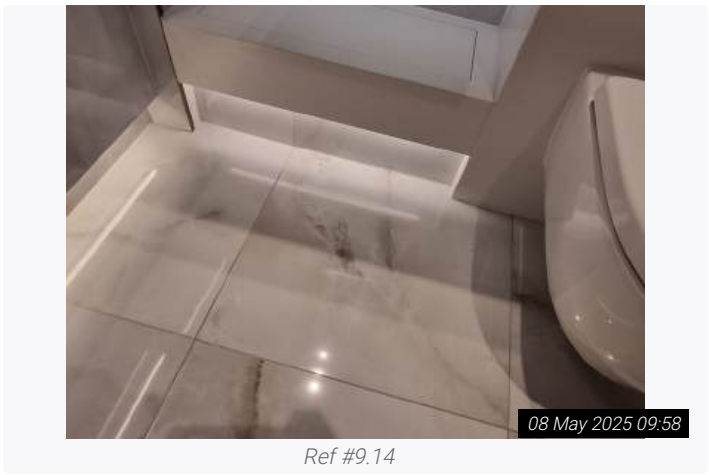
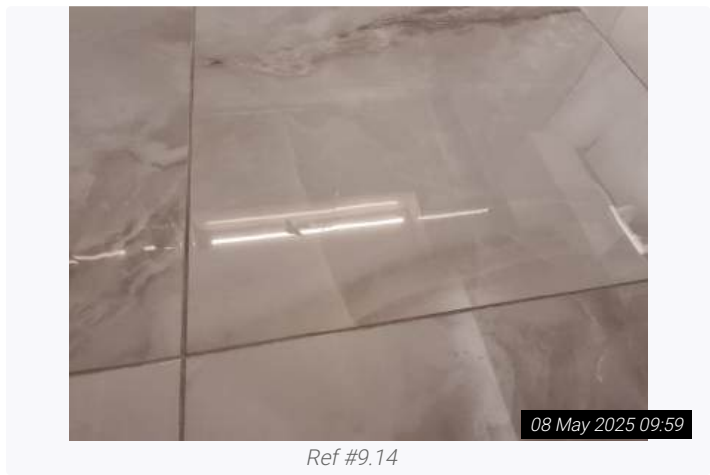
10. Bedroom 1 (Left)

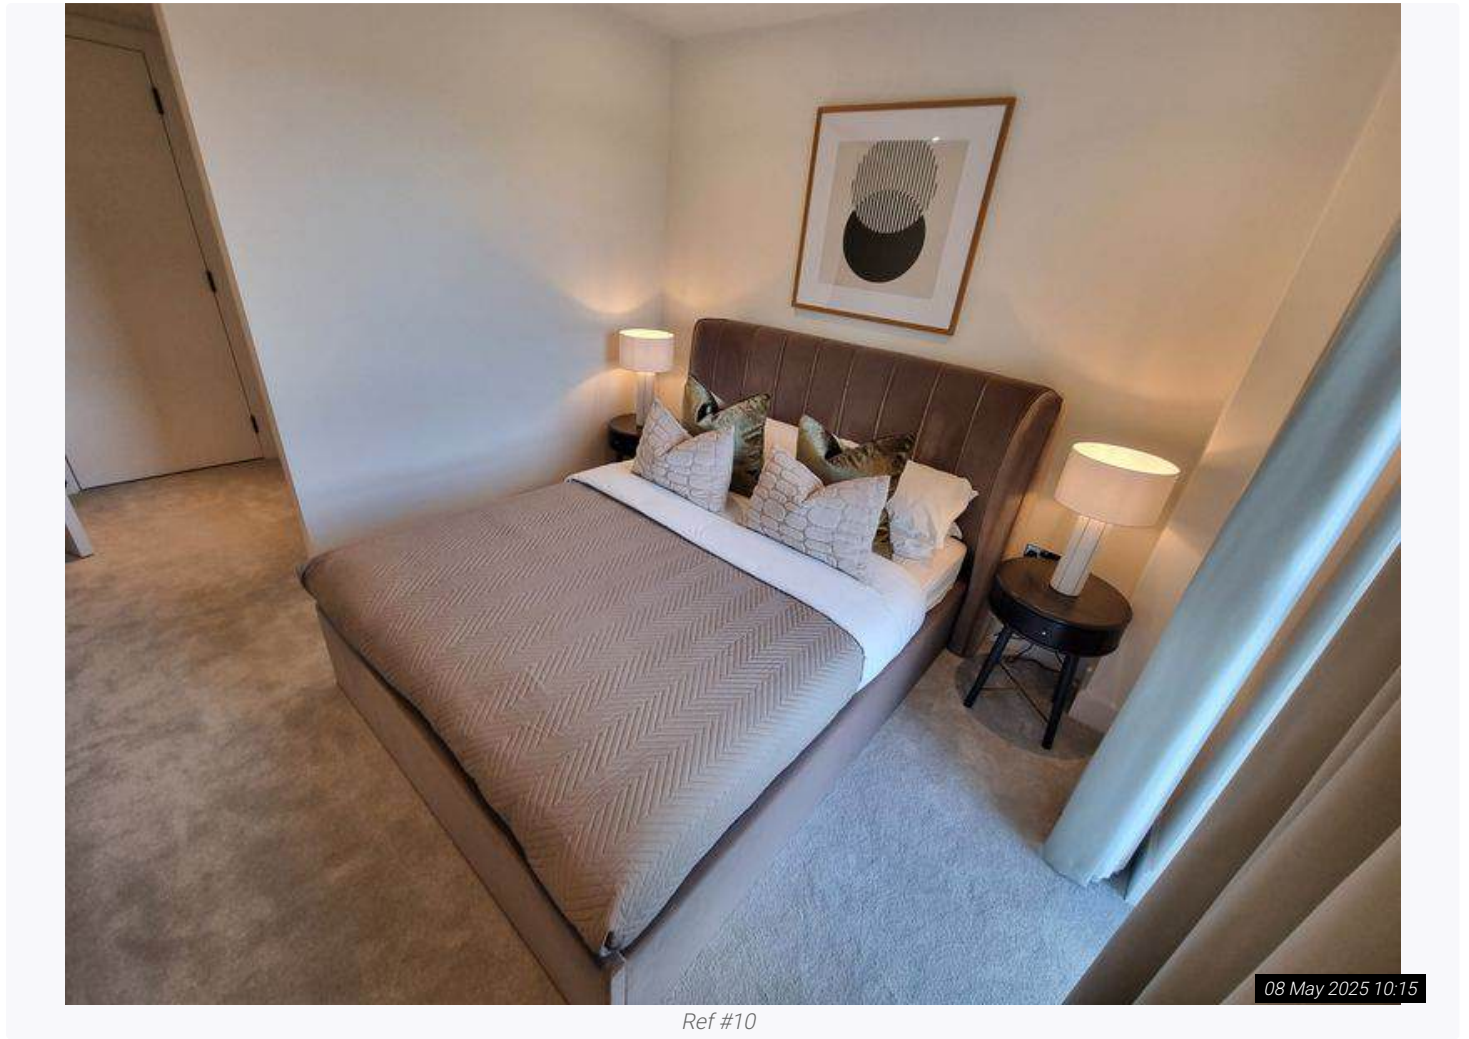
| Ref | Name | Description | Condition |

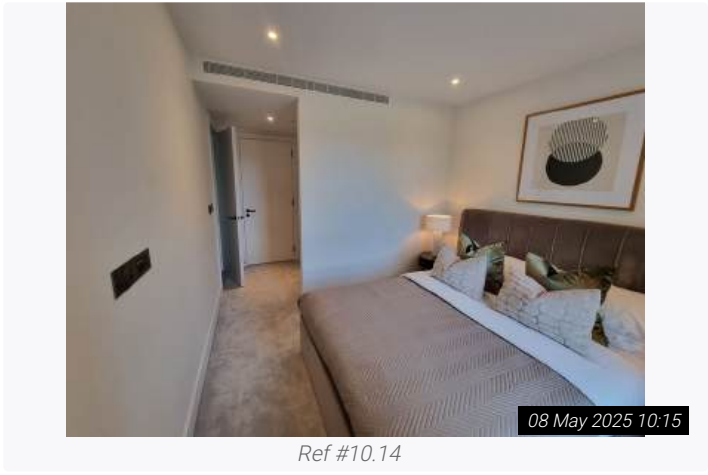
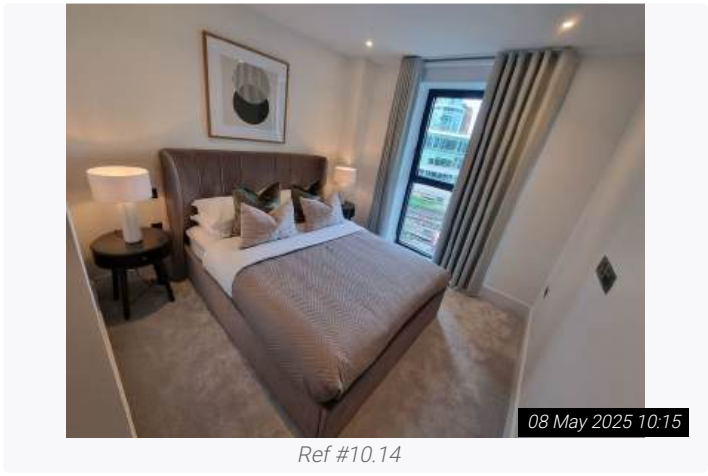
10. Bedroom 1 (Left) (Cont.)
