t: 02079364566

[info@emphasisinventories.co.uk](mailto:info@emphasisinventories.co.uk)

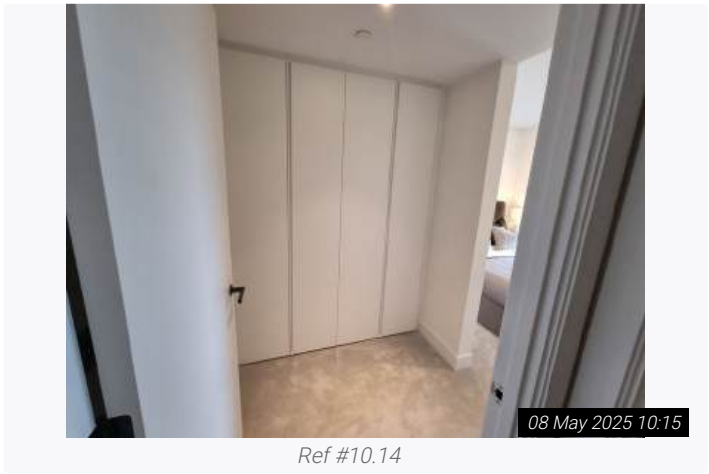
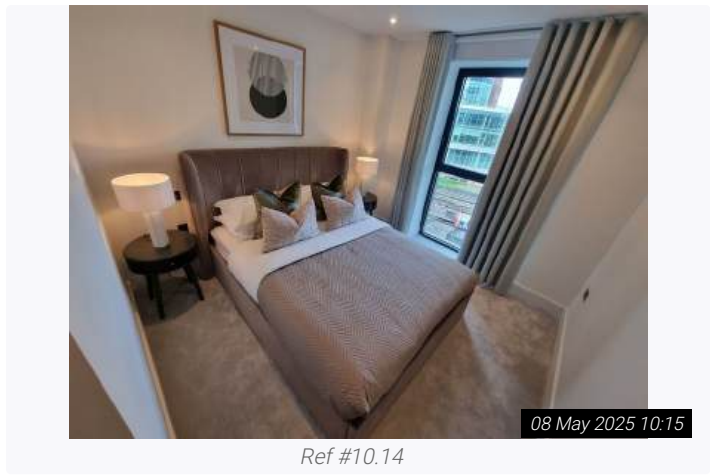
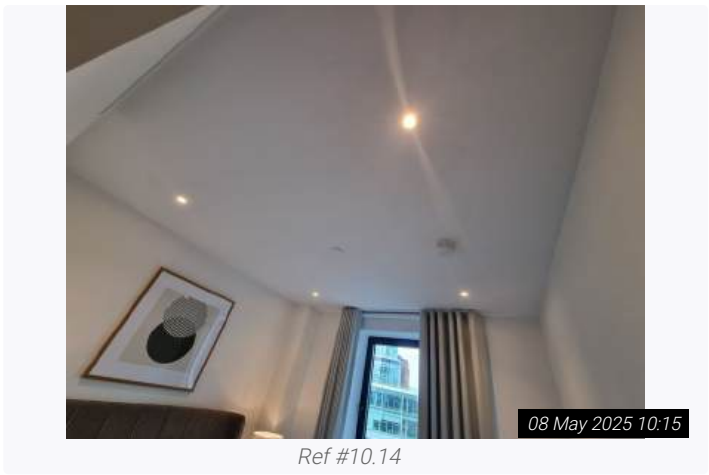
10. Bedroom 1 (Left) (Cont.)

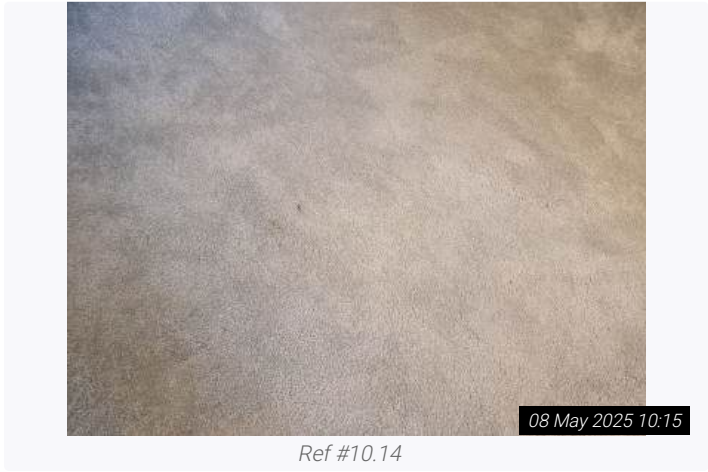
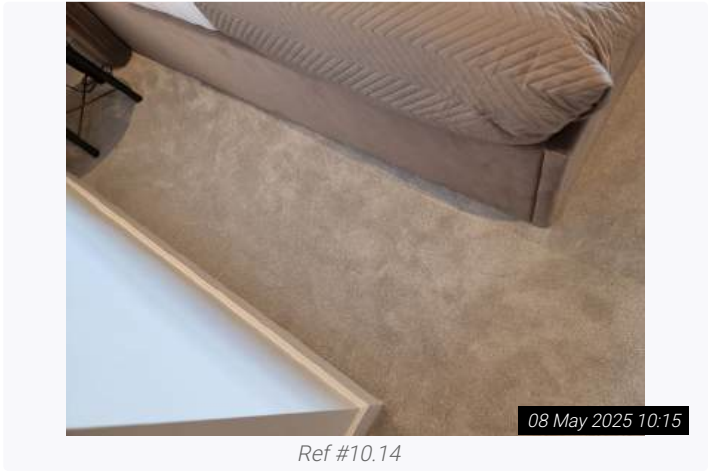
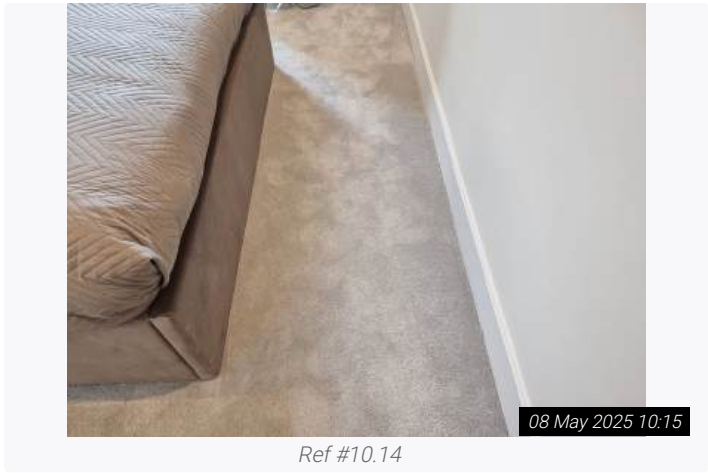
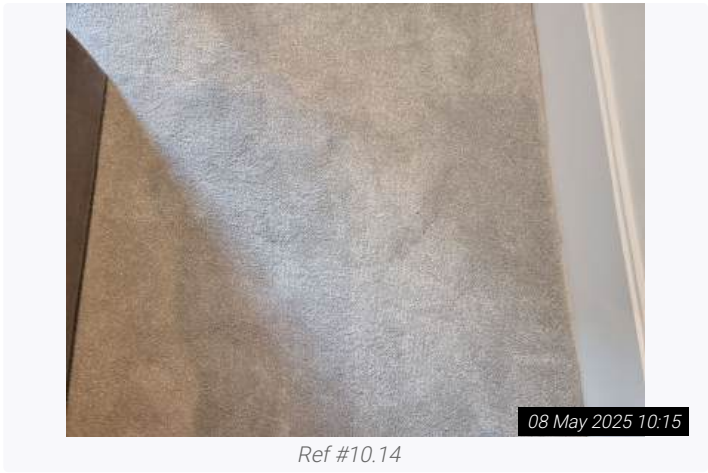
10. Bedroom 1 (Left) (Cont.)

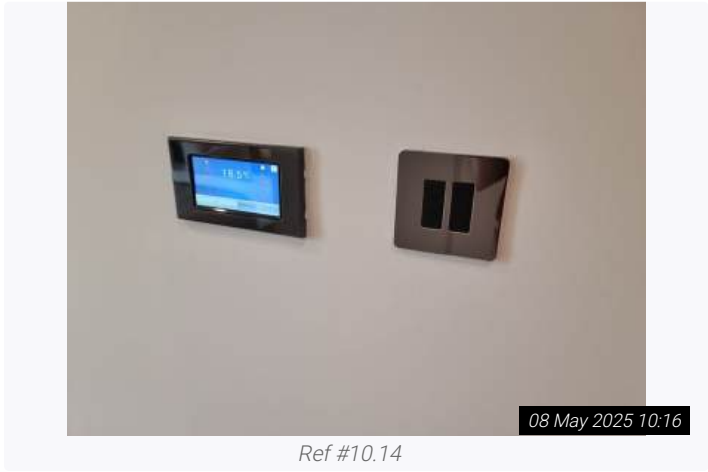
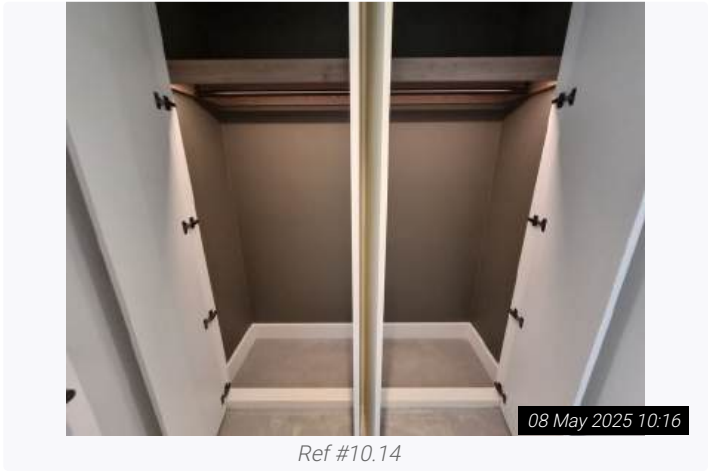
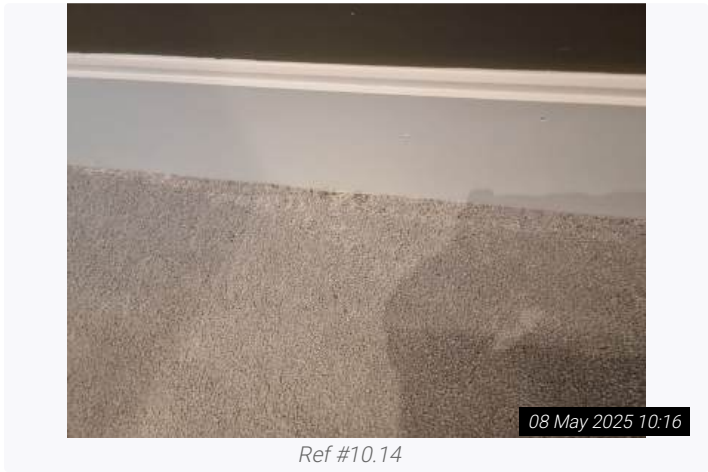
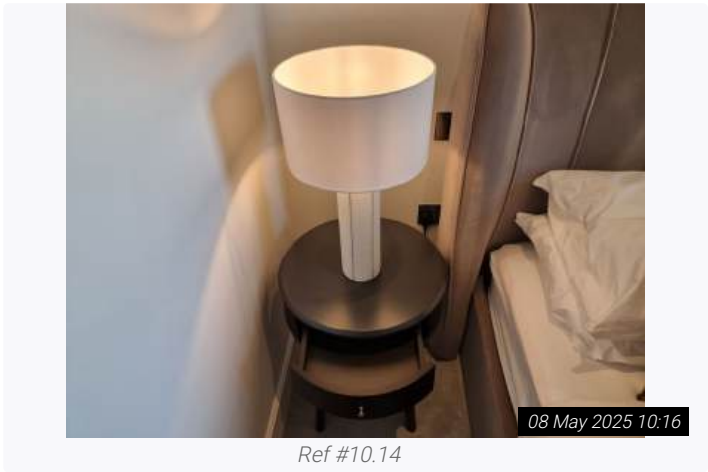
10. Bedroom 1 (Left) (Cont.)

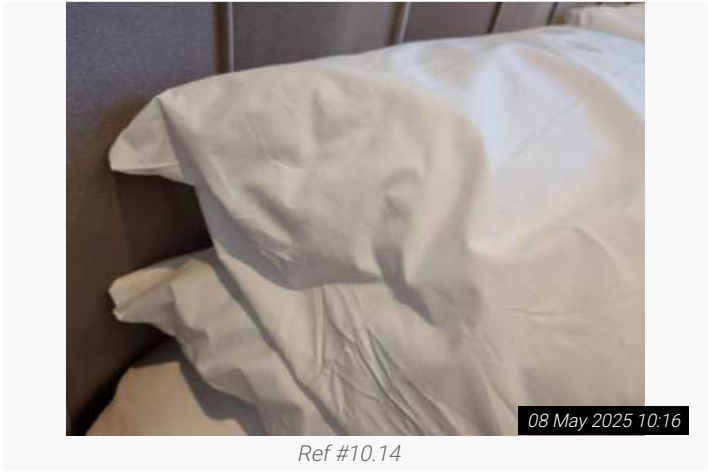
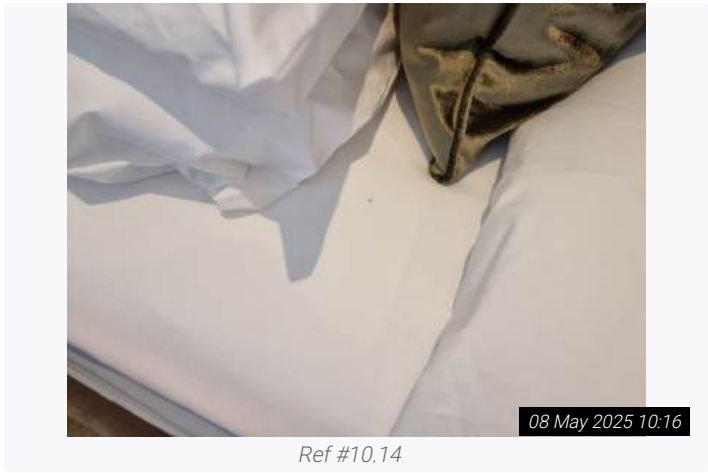
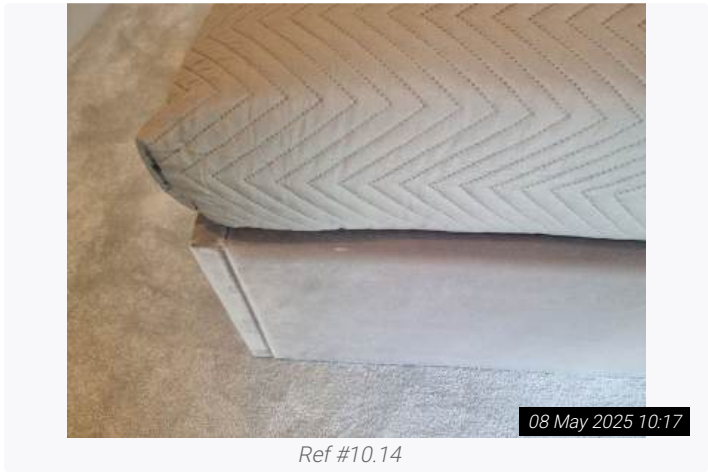
10. Bedroom 1 (Left) (Cont.)

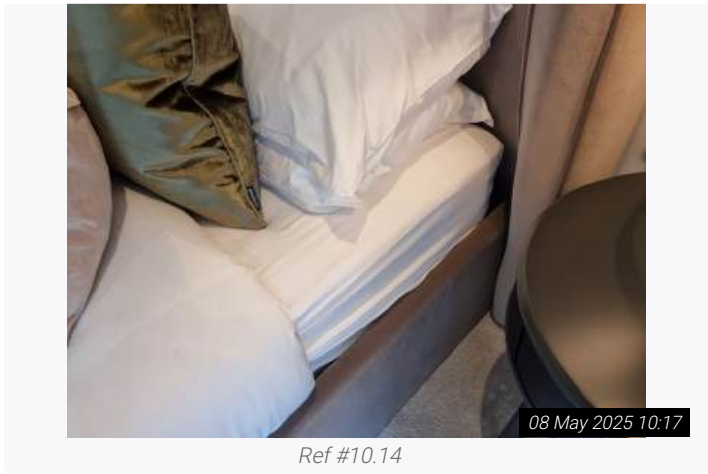
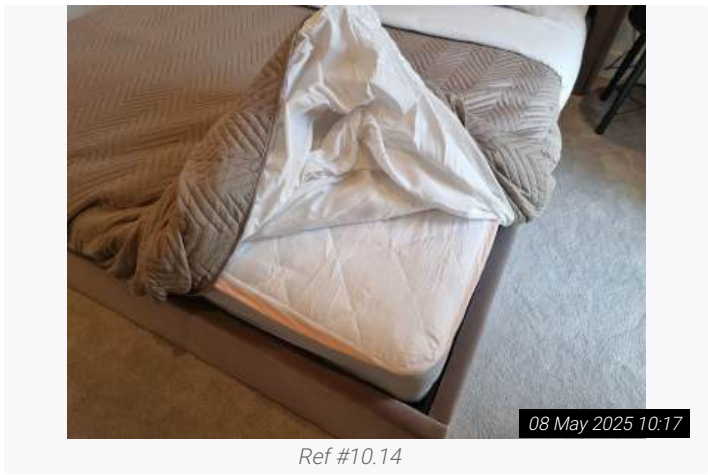
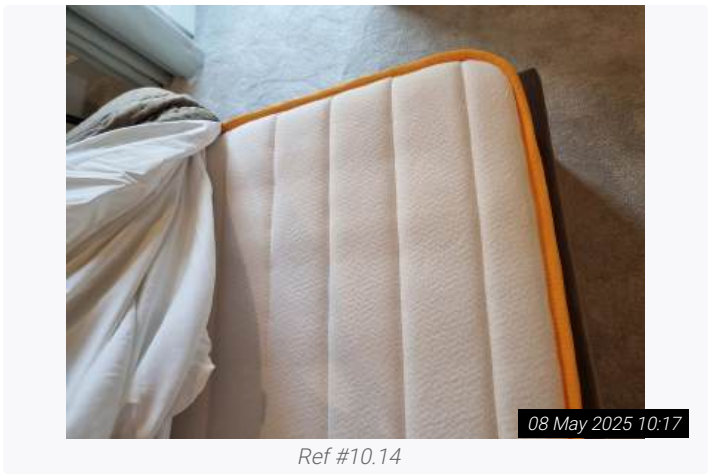
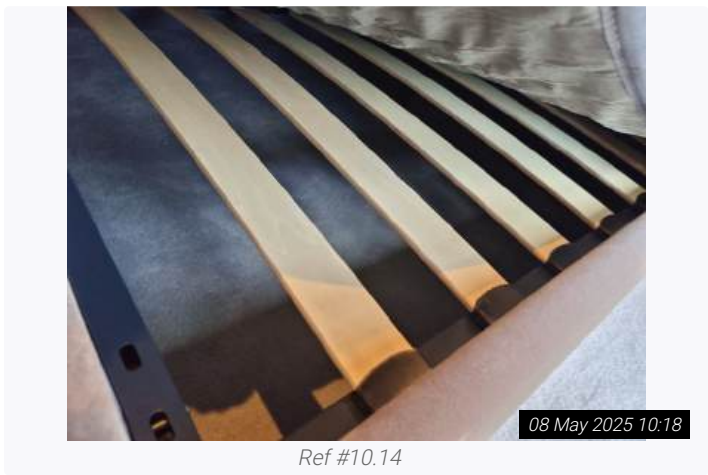
10. Bedroom 1 (Left) (Cont.)

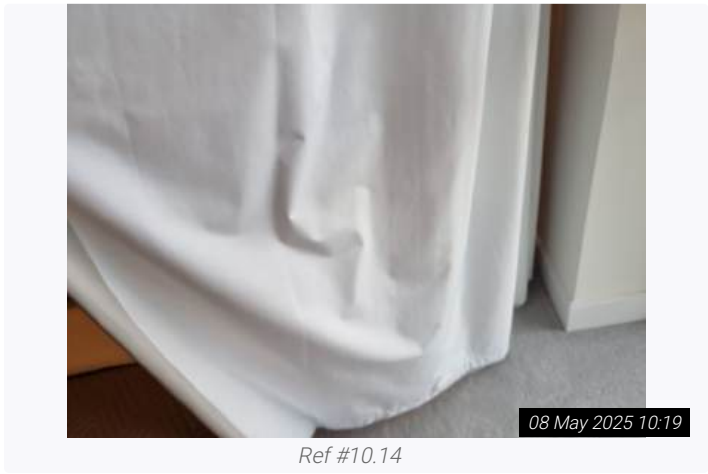
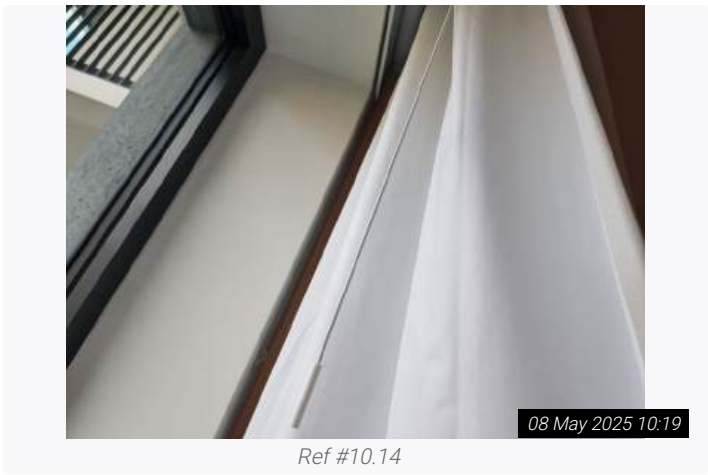
10. Bedroom 1 (Left) (Cont.)

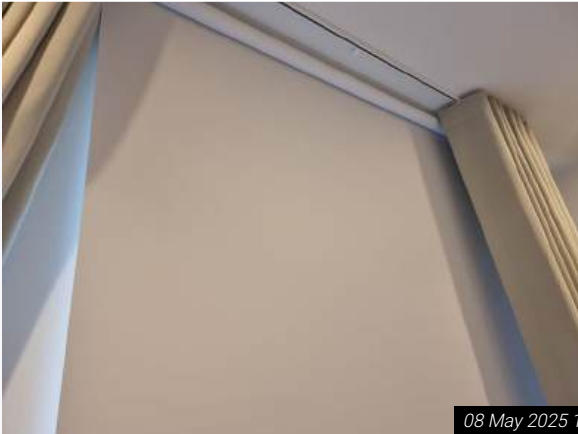
| Ref | Name | Description | Condition |
|---|---|---|---|
| | | <div>08 May 2025 10:19</div> <div>Ref #10.14</div> | |

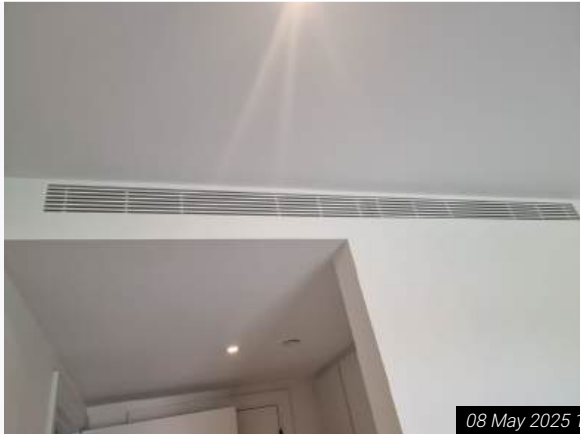
| Ref | Name | Description | Condition |
|---|---|---|---|
| | | <div>08 May 2025 10:19</div> <div>Ref #10.14</div> | |

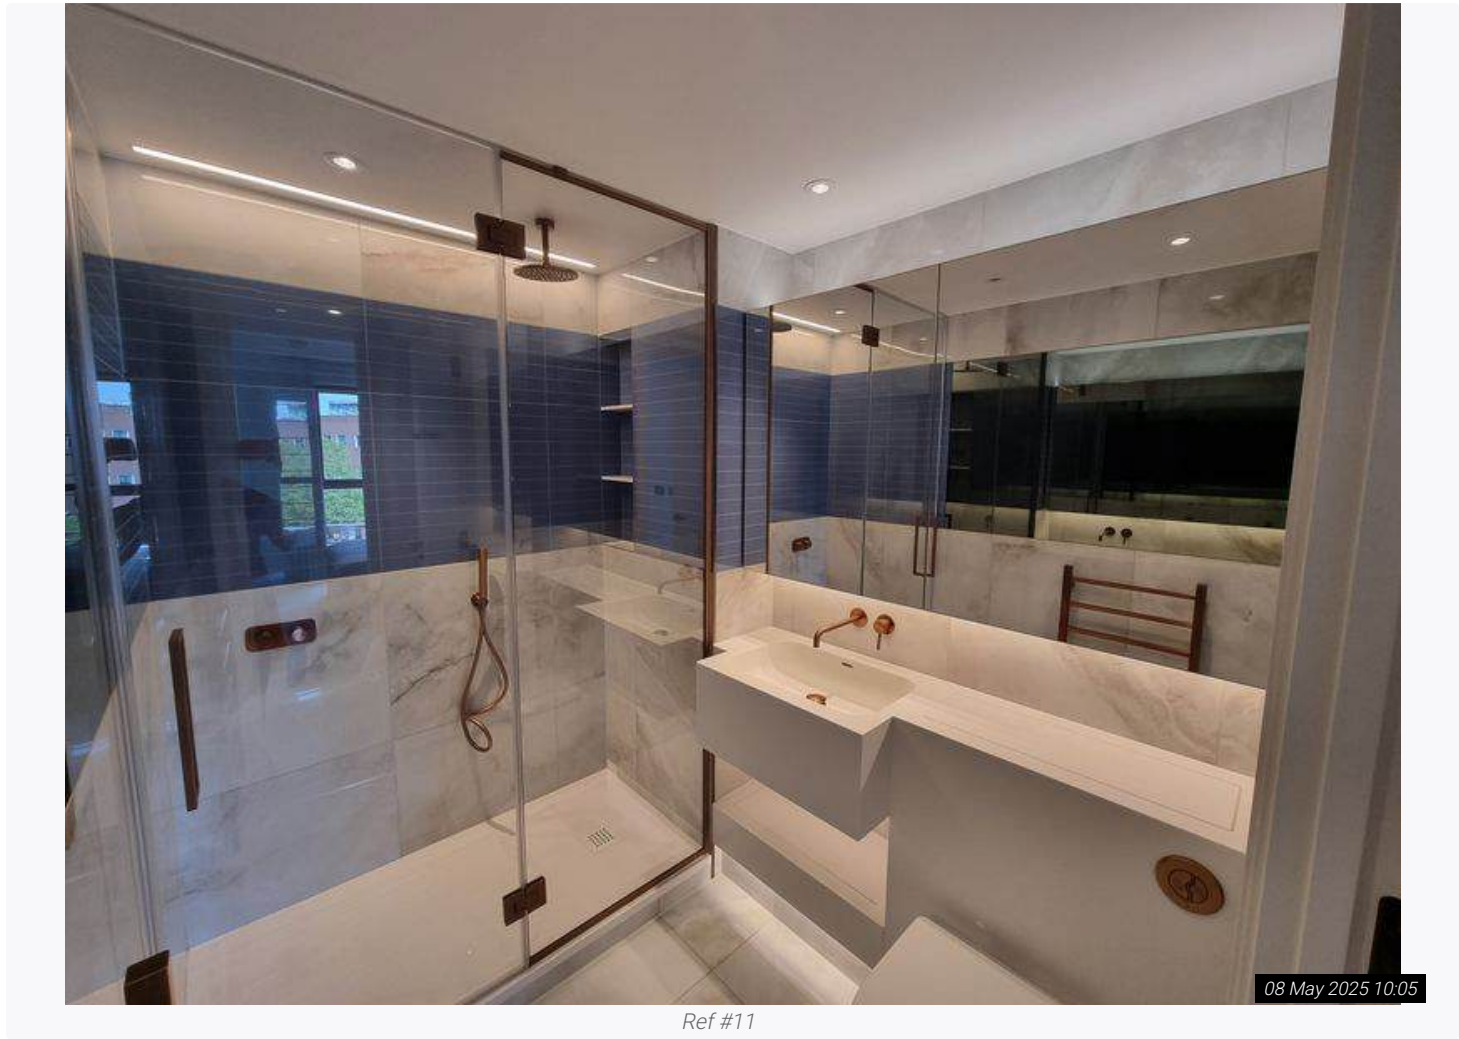
| Ref | Name | Description | Condition |

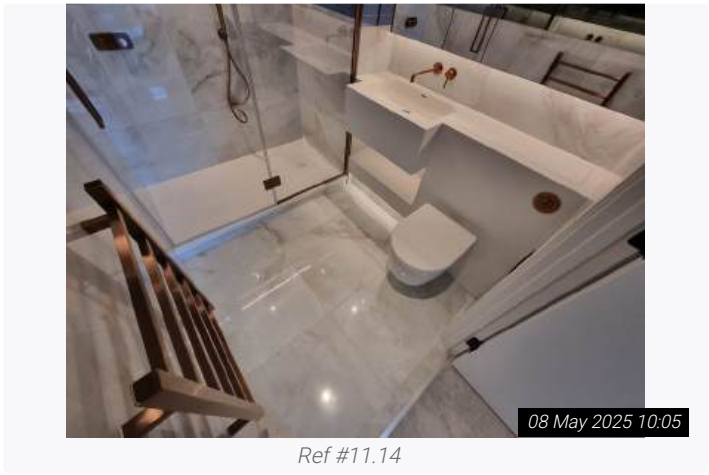
11. En Suite Shower Room (Cont.)

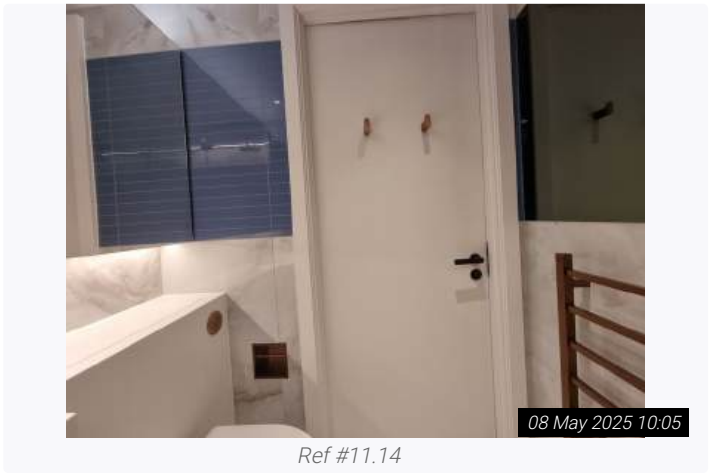
11. En Suite Shower Room (Cont.)

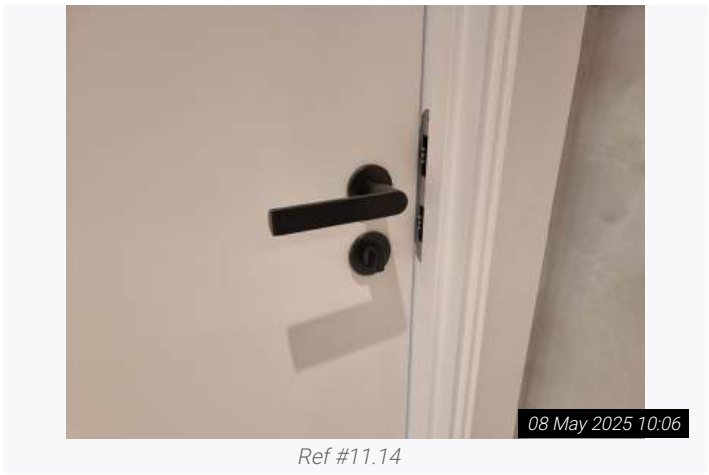
11. En Suite Shower Room (Cont.)

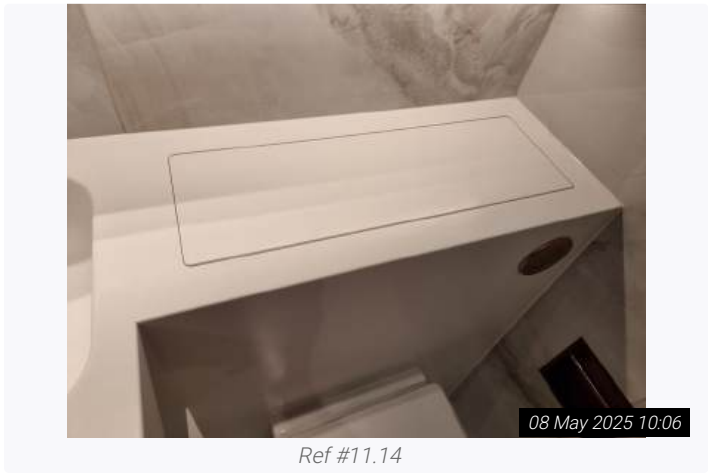
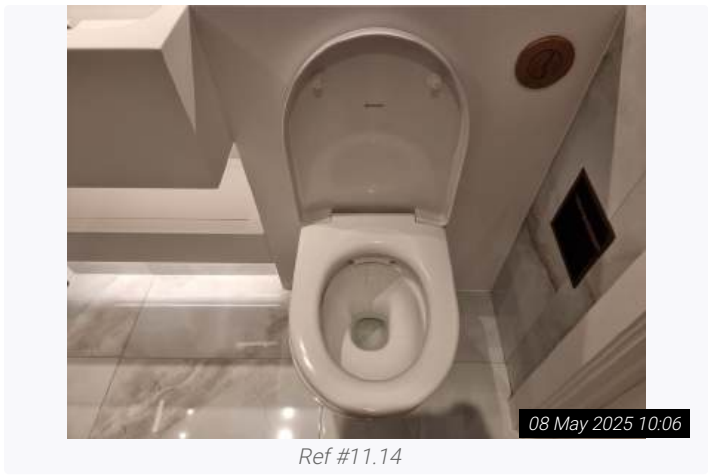
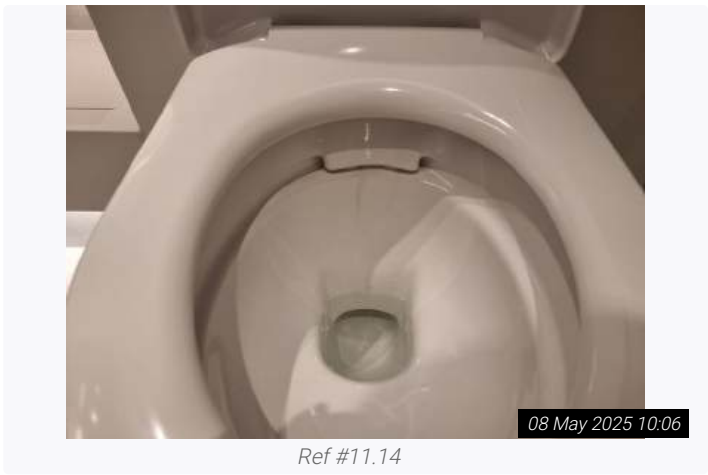
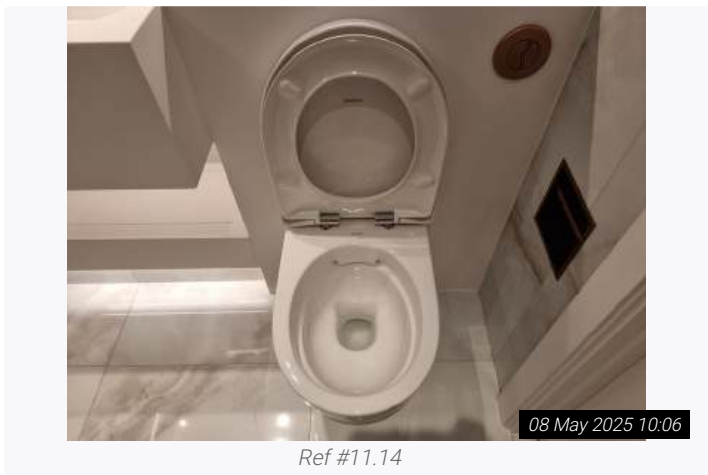
11. En Suite Shower Room (Cont.)

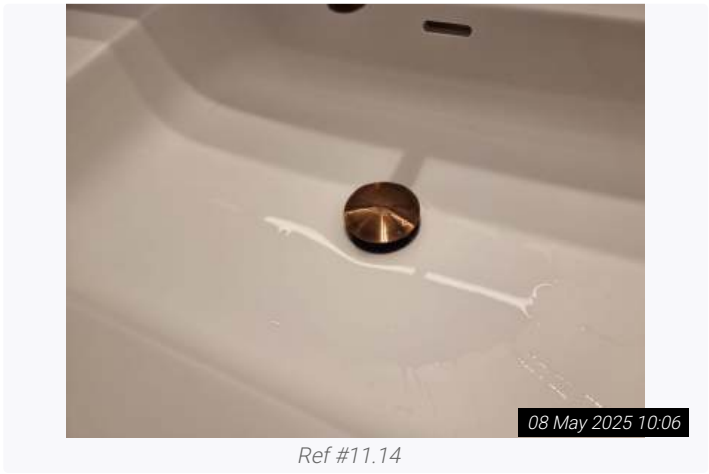
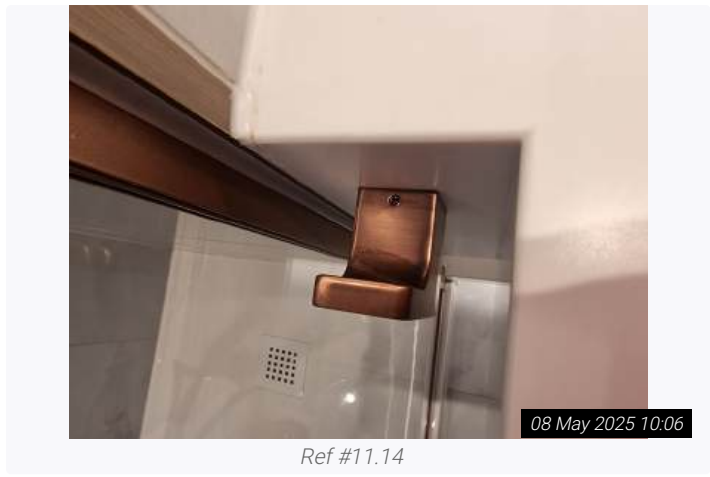
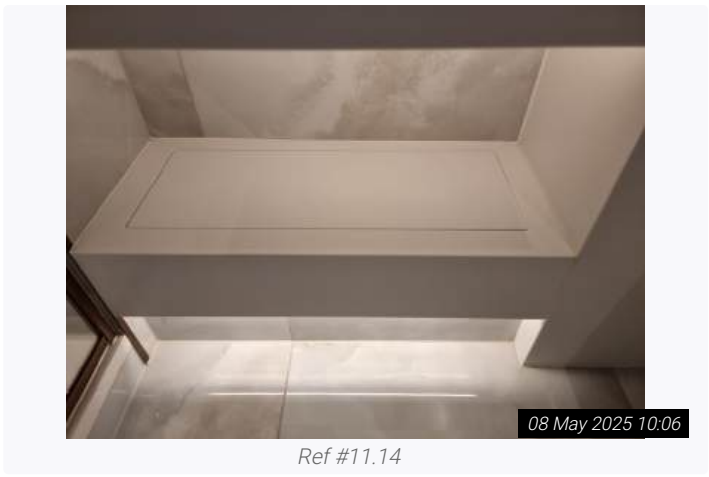
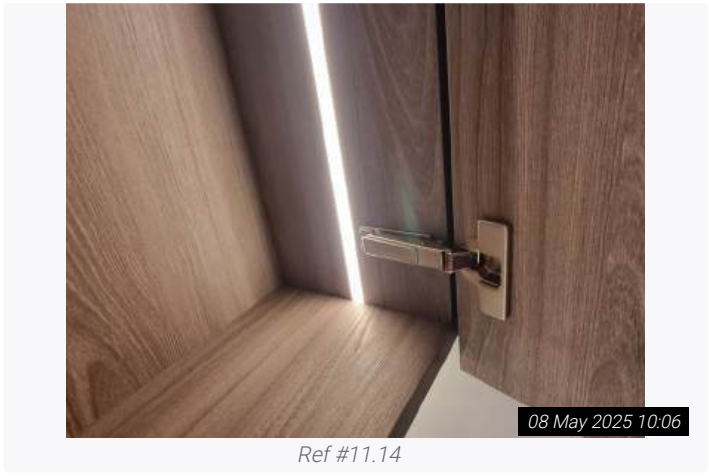
11. En Suite Shower Room (Cont.)

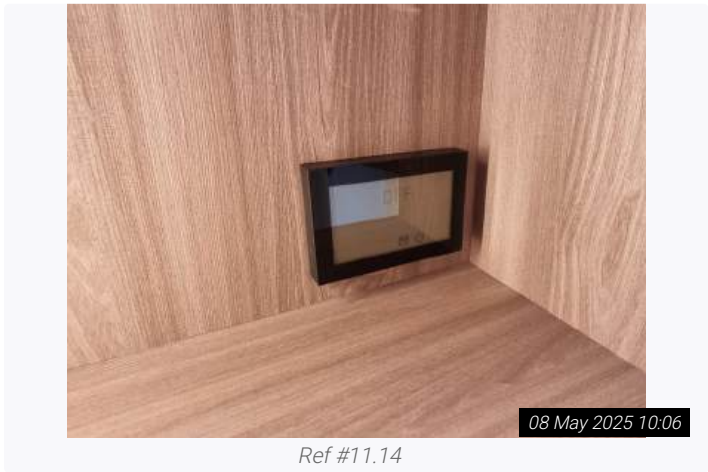
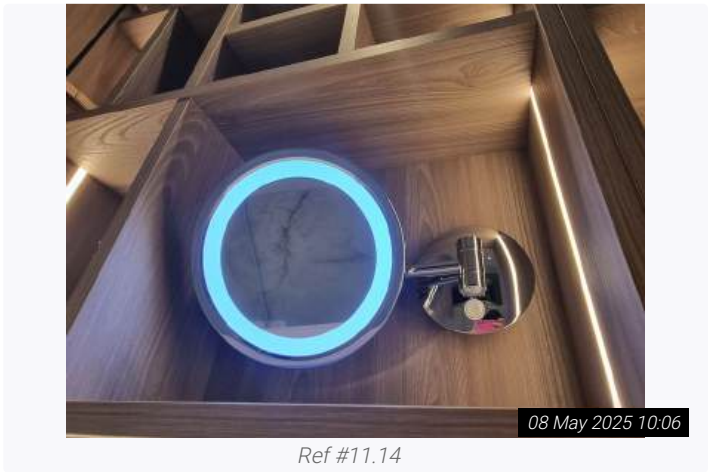
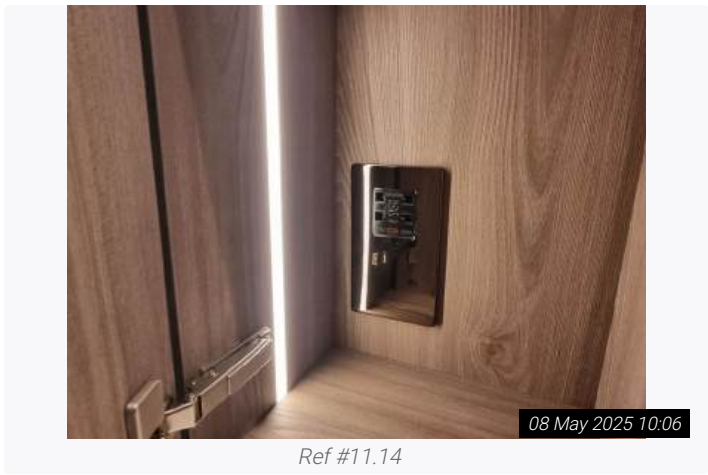
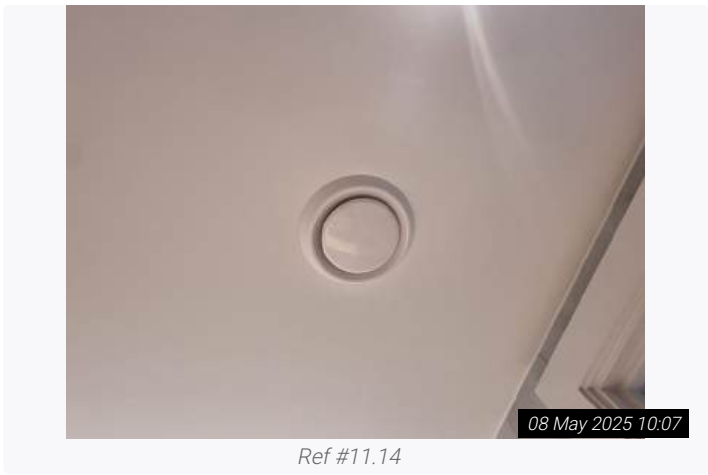
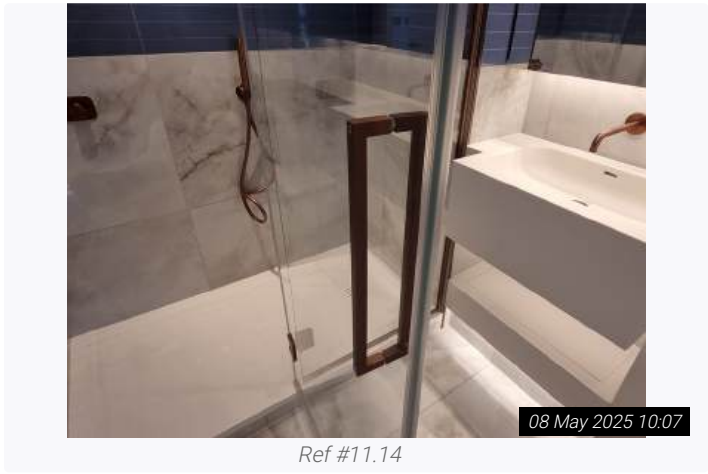
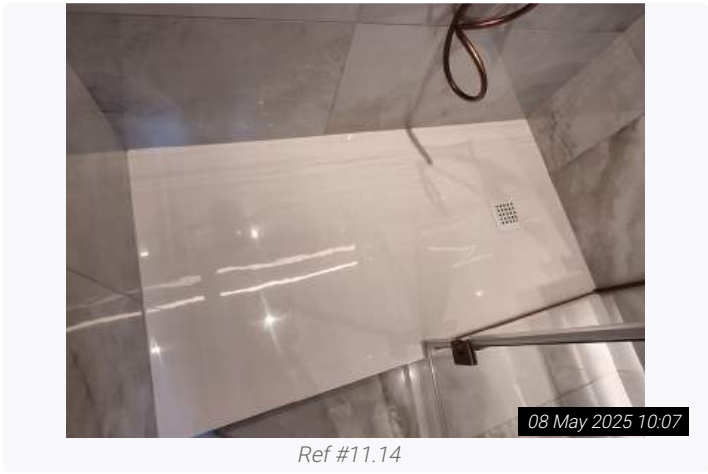
11. En Suite Shower Room (Cont.)

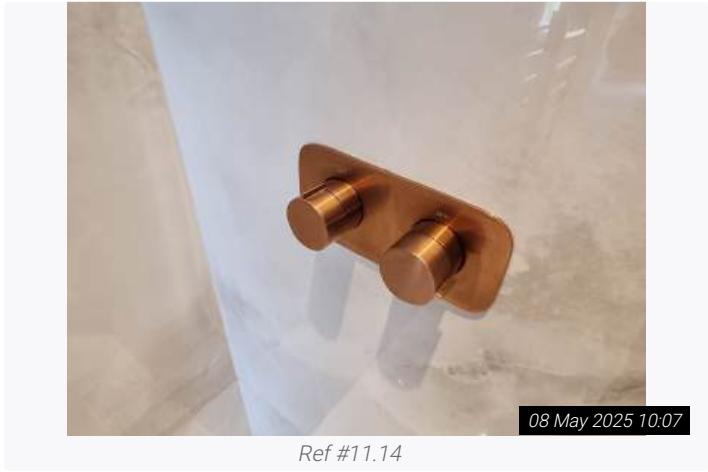
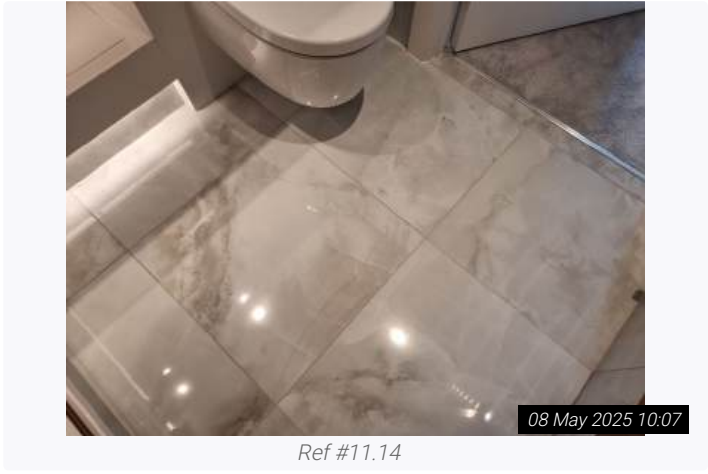
11. En Suite Shower Room (Cont.)

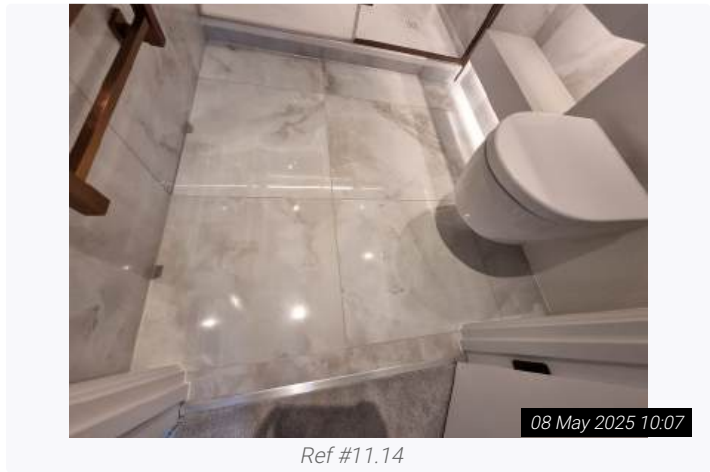
| Ref | Name | Description | Condition |

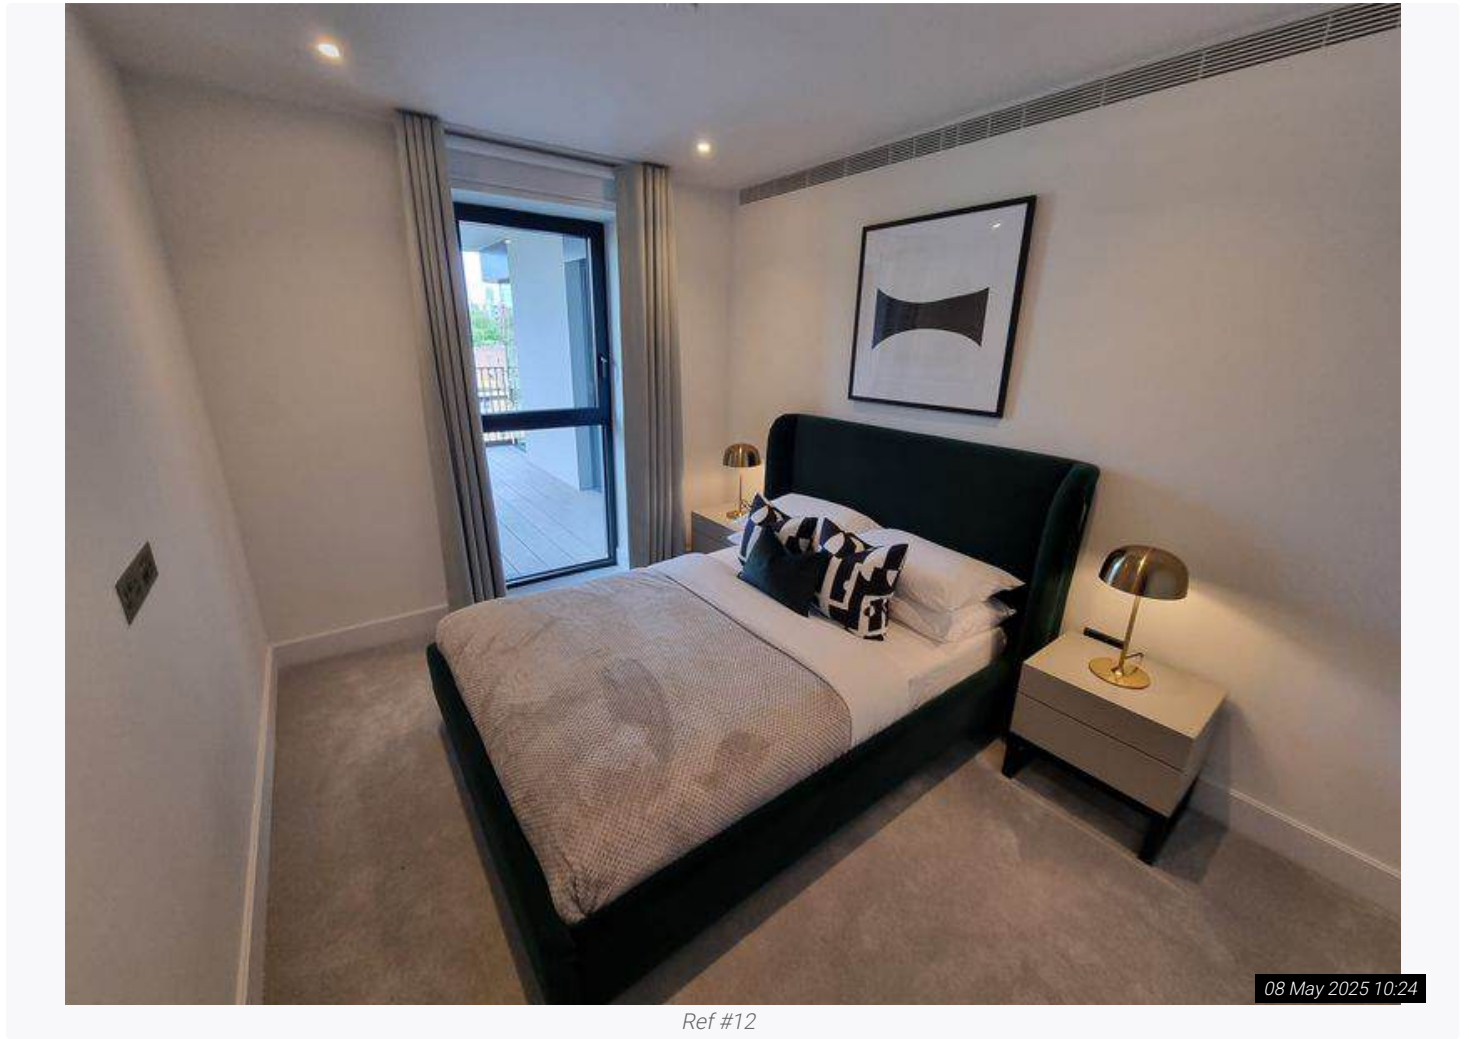
| Ref | Name | Description | Condition |

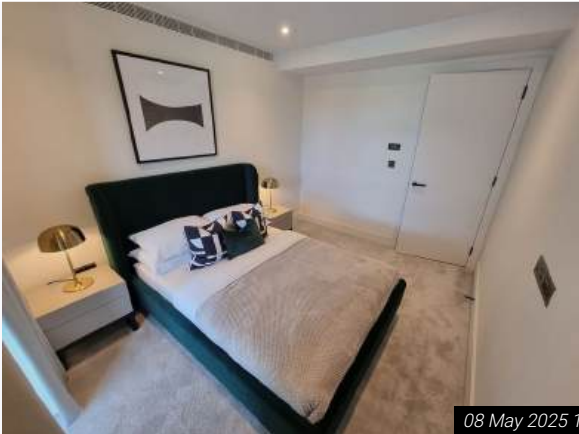
| Ref | Name | Description | Condition |

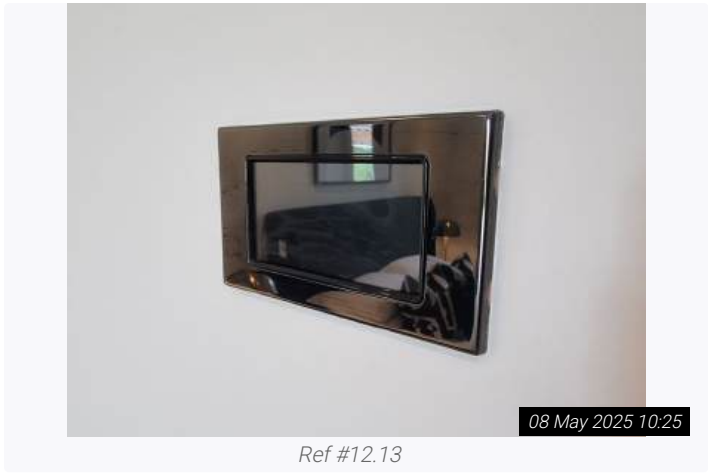
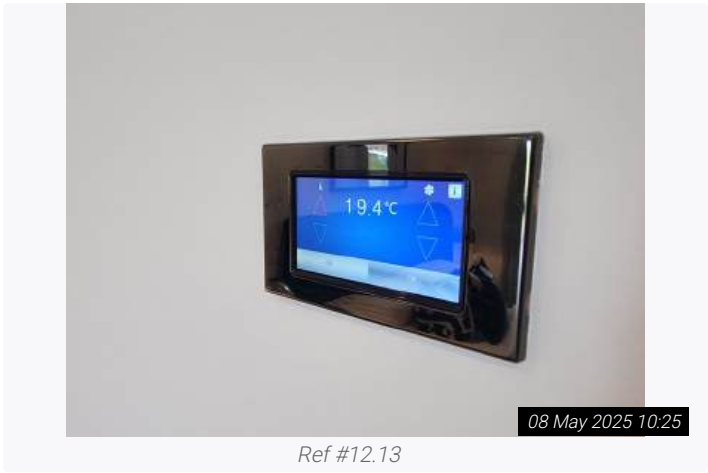
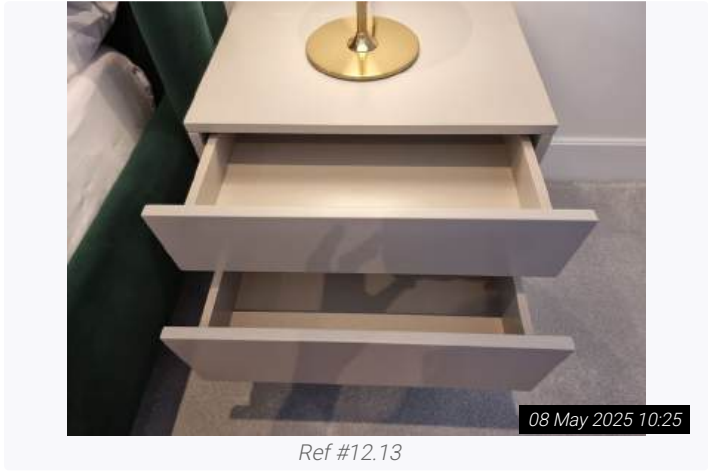
12. Bedroom 2 (Cont.)

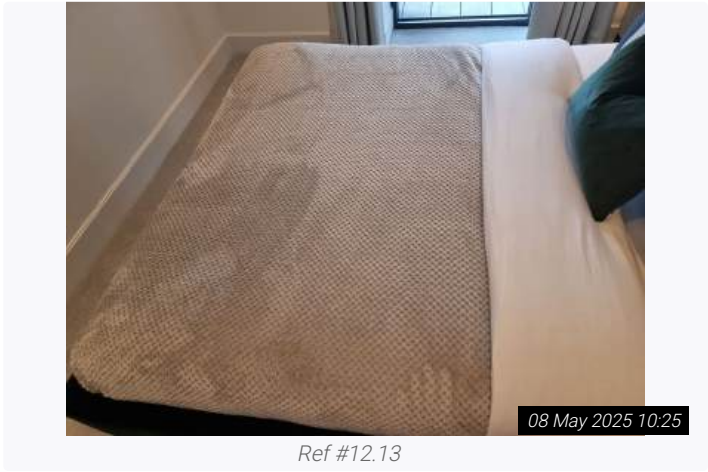
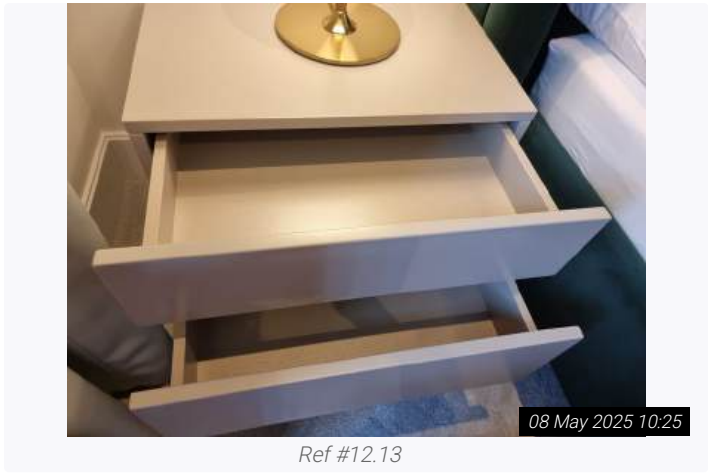
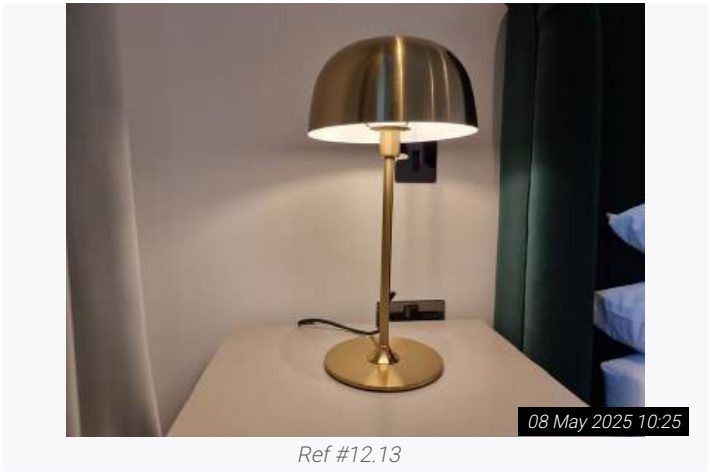
12. Bedroom 2 (Cont.)

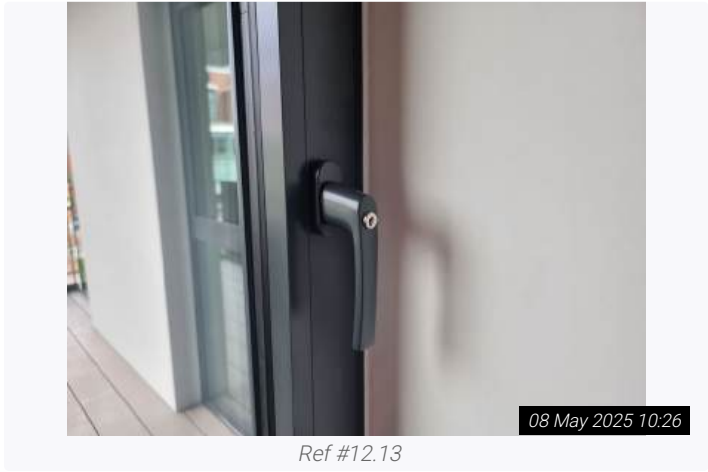
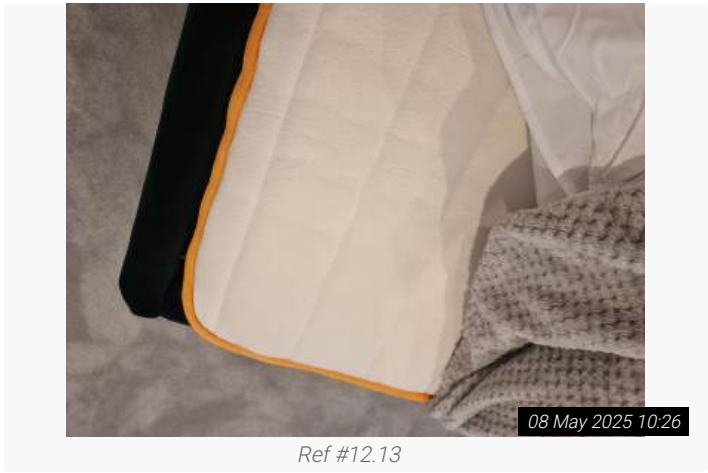
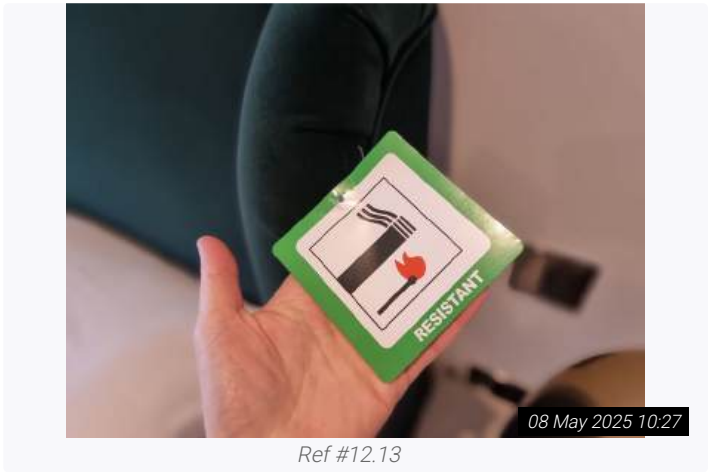
12. Bedroom 2 (Cont.)

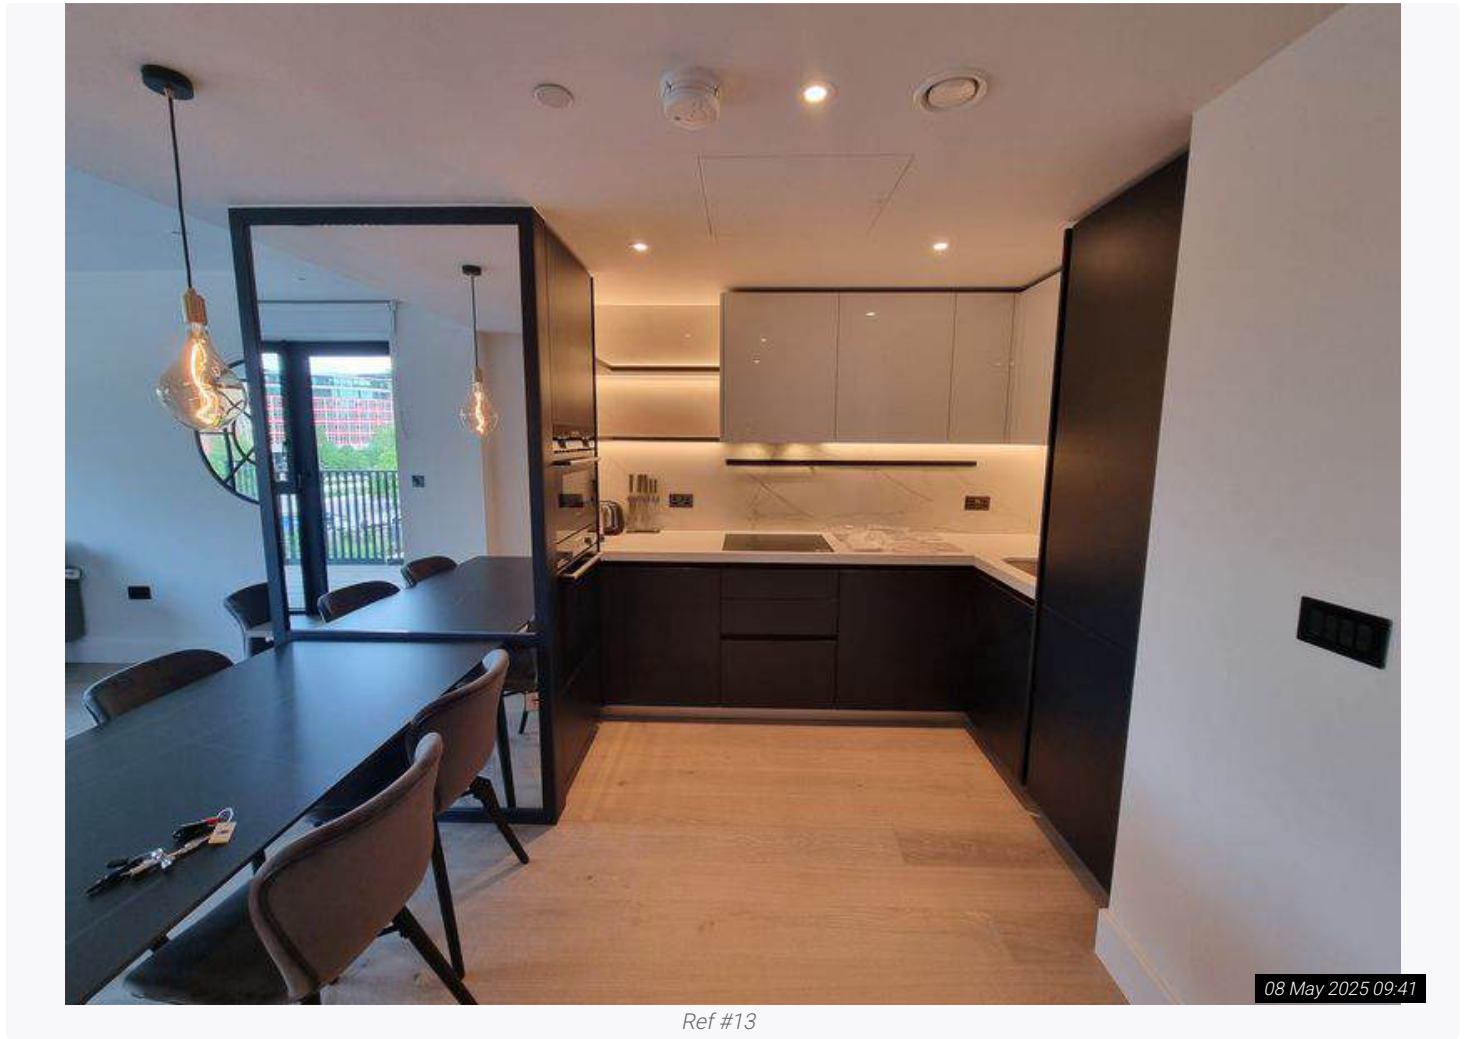
| Ref | Name | Description | Condition |

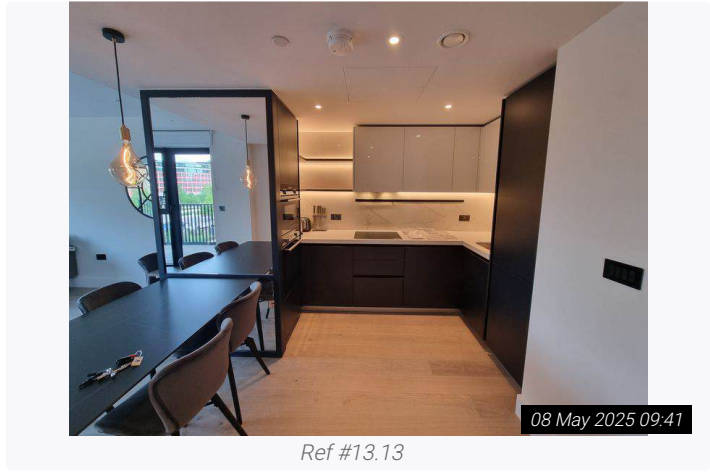
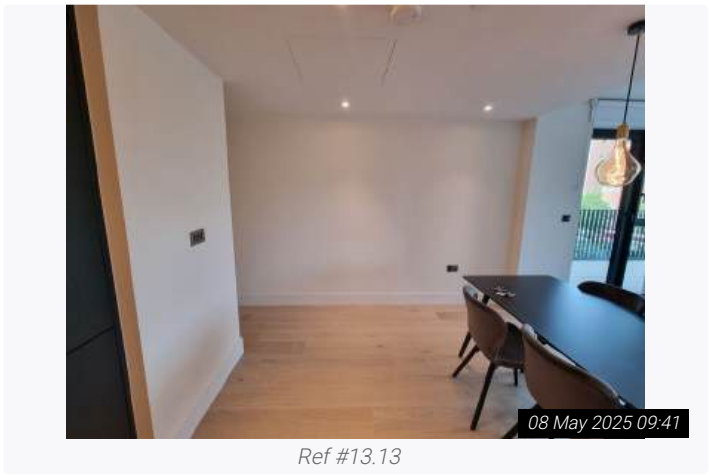
13. Open Plan Kitchen (Cont.)

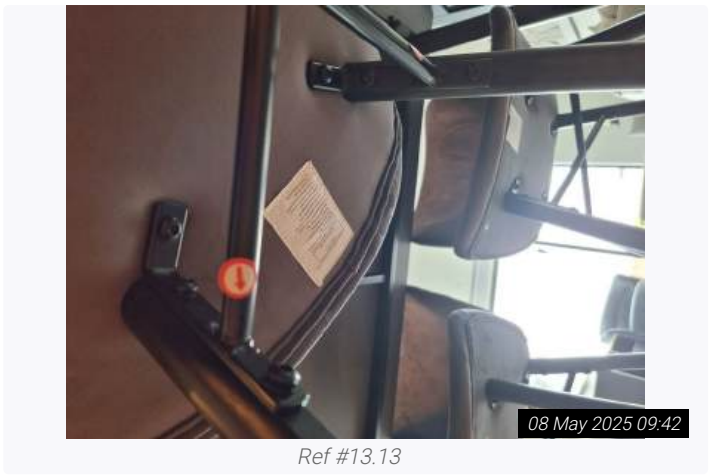
13. Open Plan Kitchen (Cont.)
