t: 02079364566

[info@emphasisinventories.co.uk](mailto:info@emphasisinventories.co.uk)

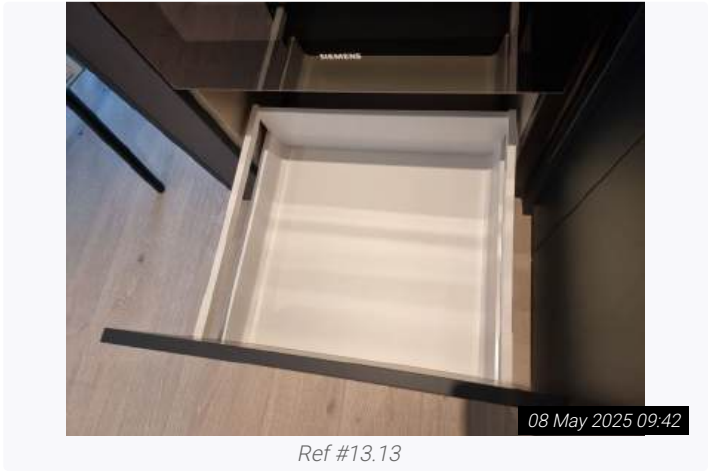
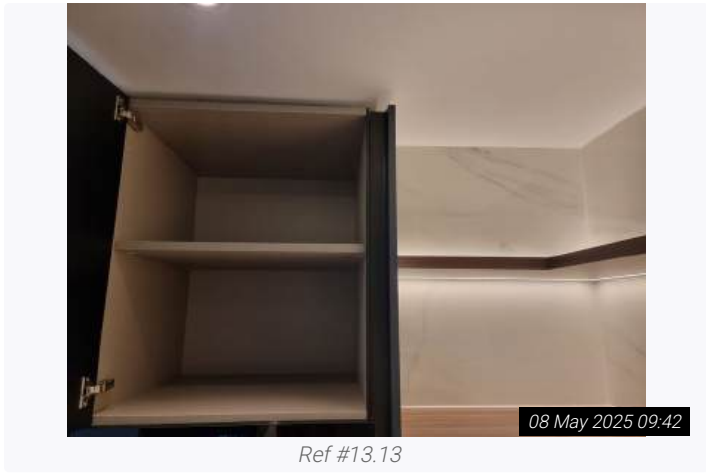
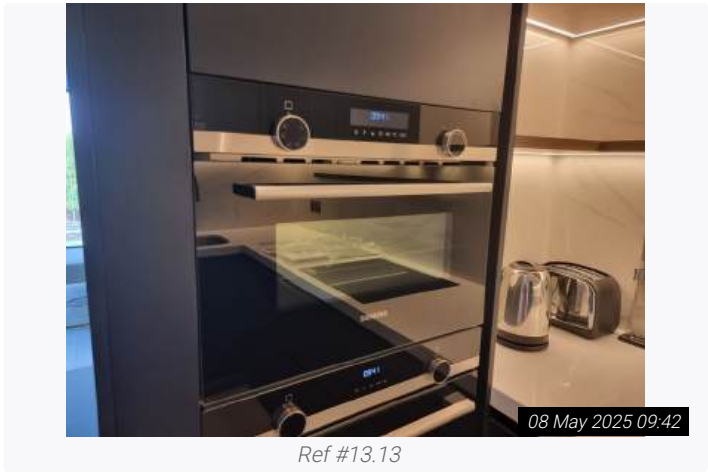
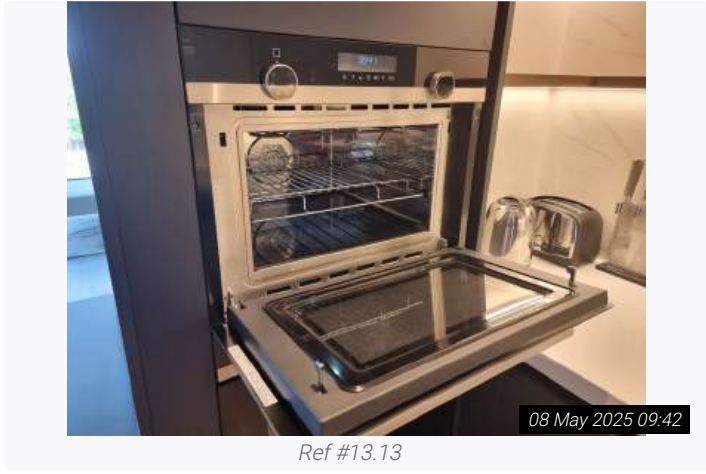
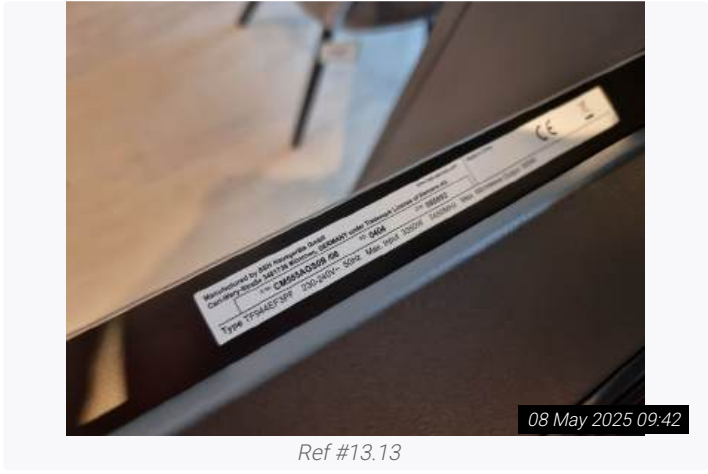
13. Open Plan Kitchen (Cont.)

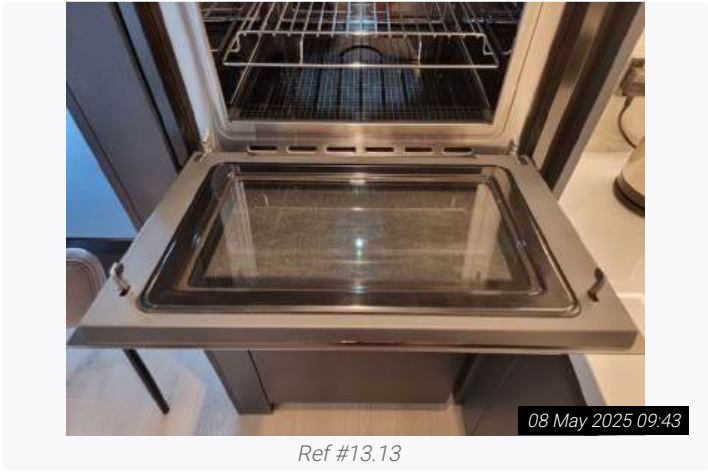
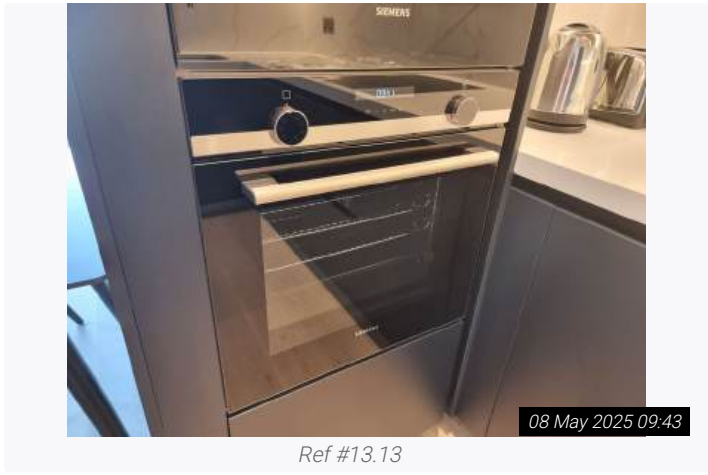
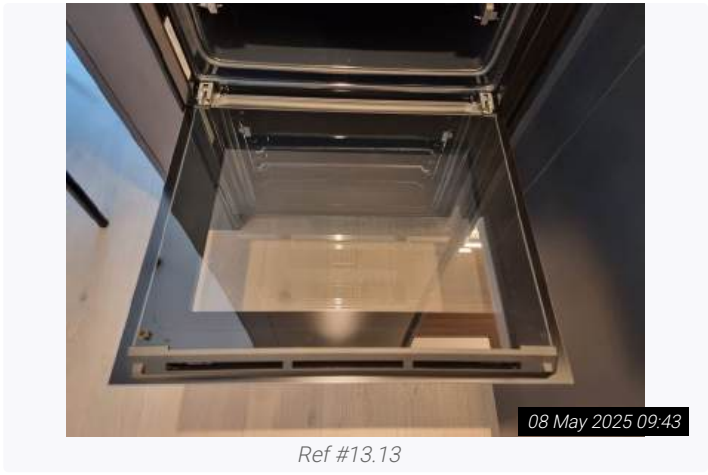
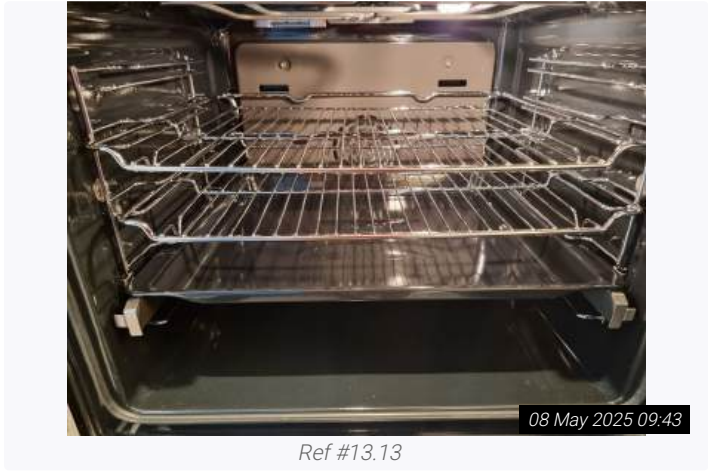
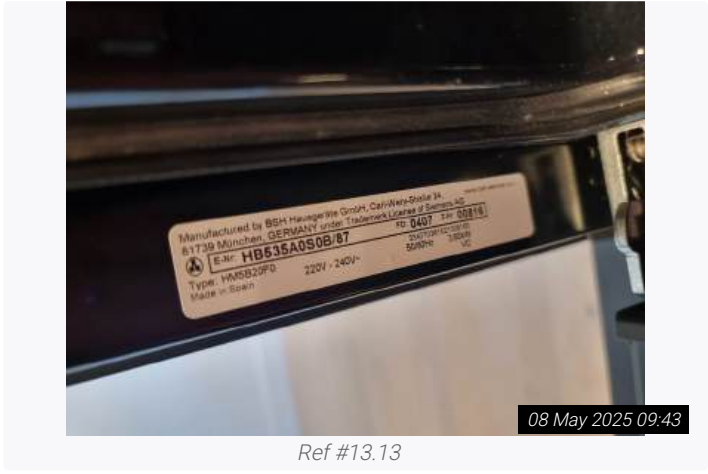
13. Open Plan Kitchen (Cont.)

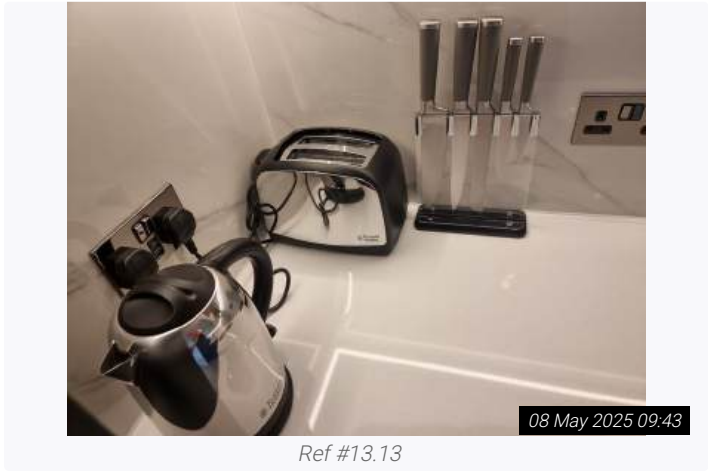
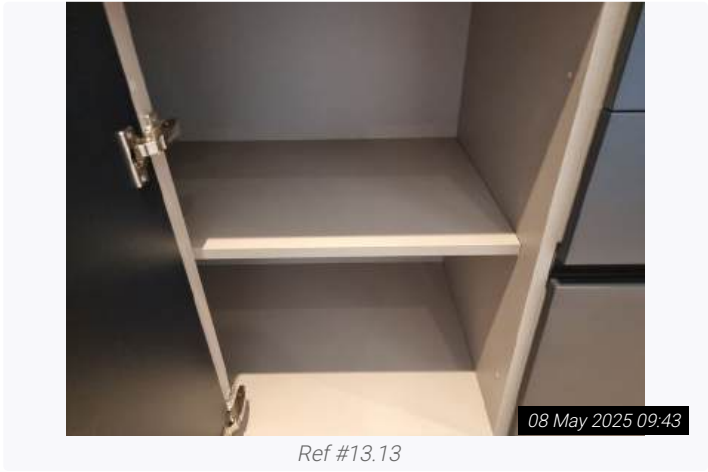
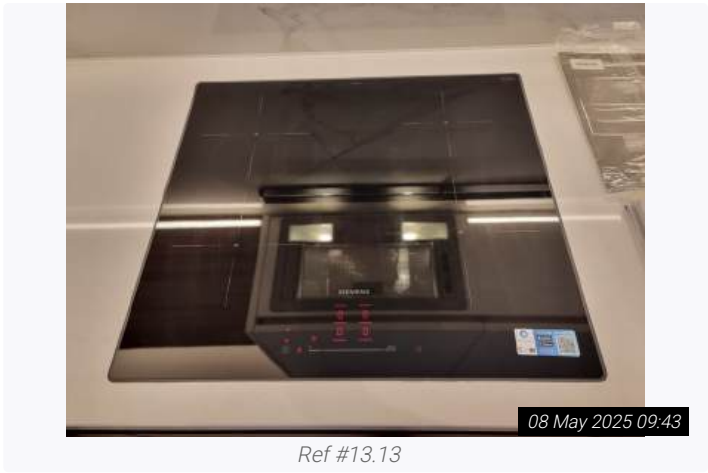
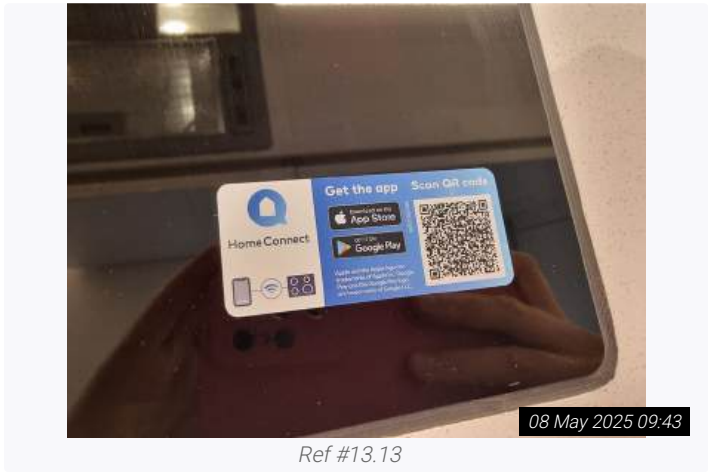
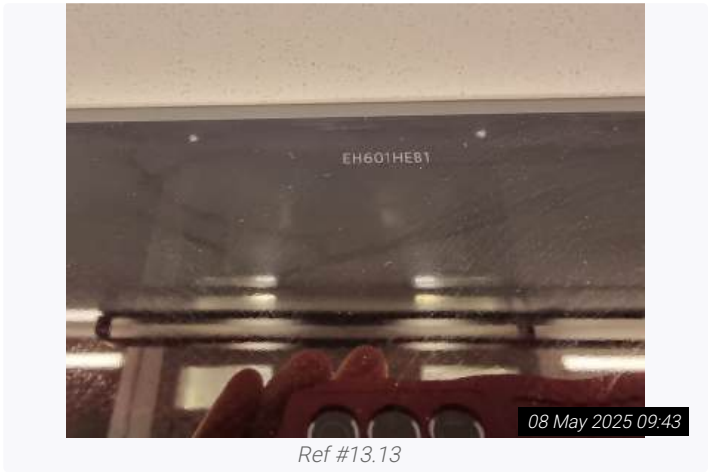
13. Open Plan Kitchen (Cont.)

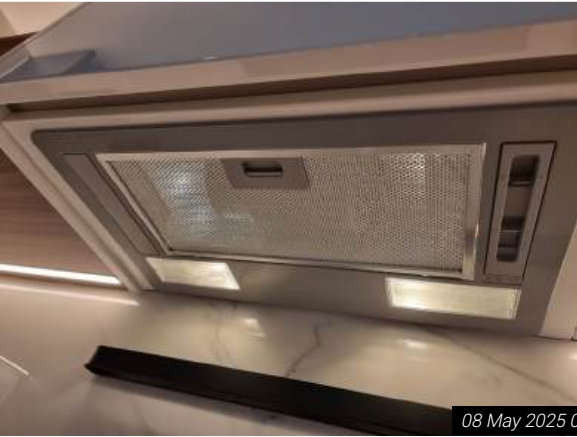
| Ref | Name | Description | Condition |

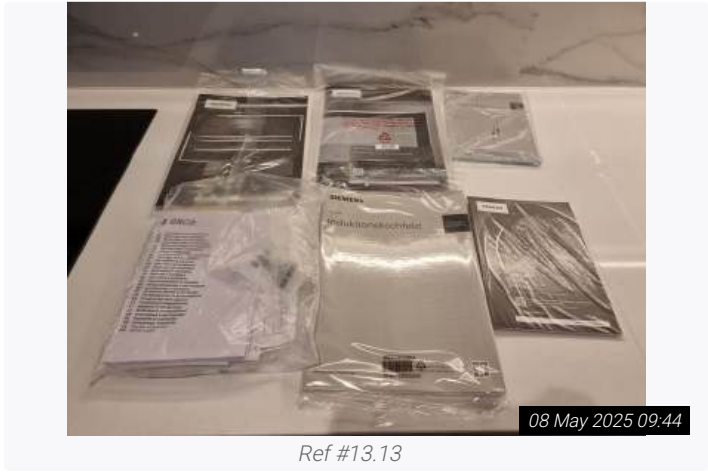
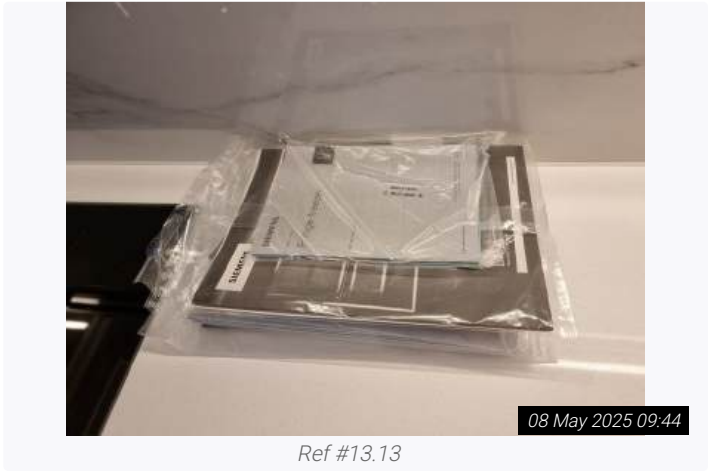
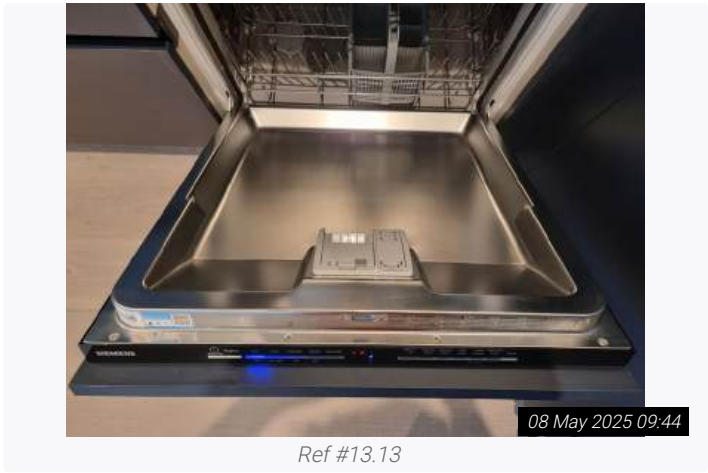
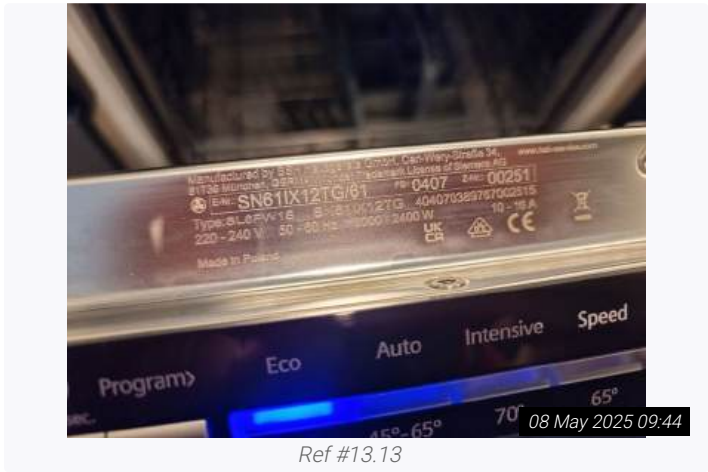
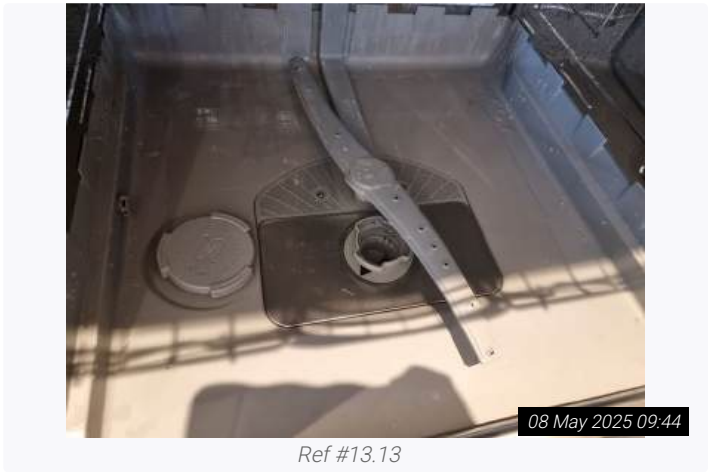
13. Open Plan Kitchen (Cont.)

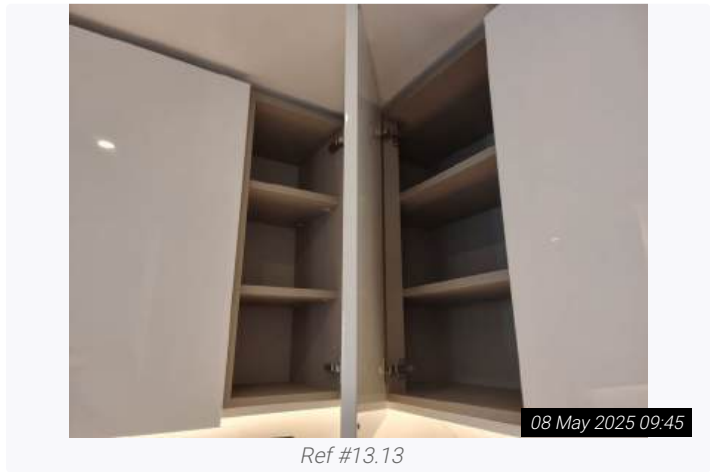
13. Open Plan Kitchen (Cont.)

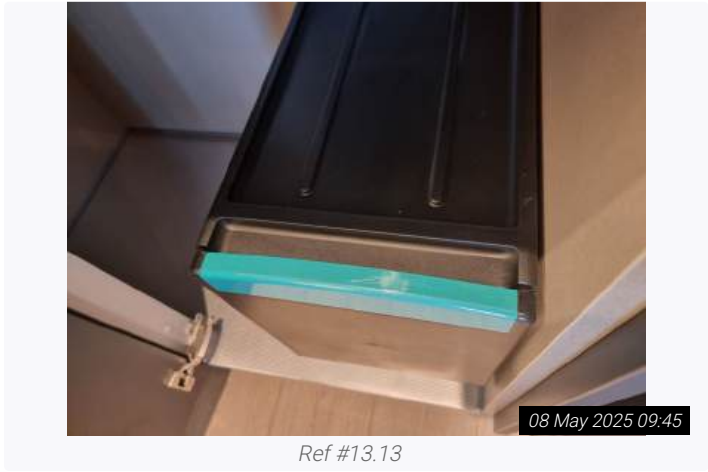
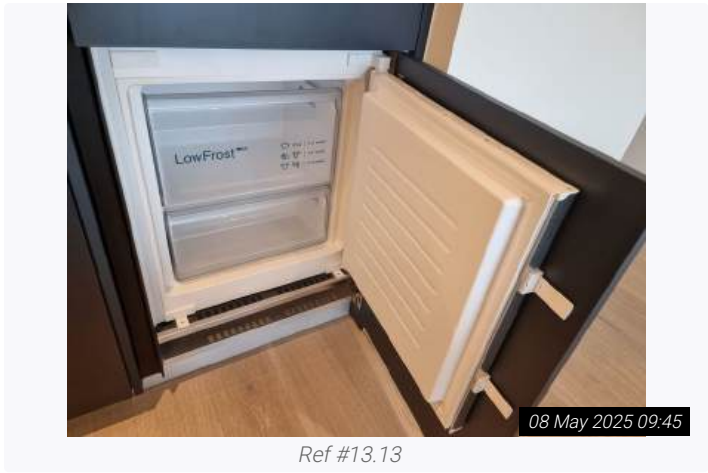
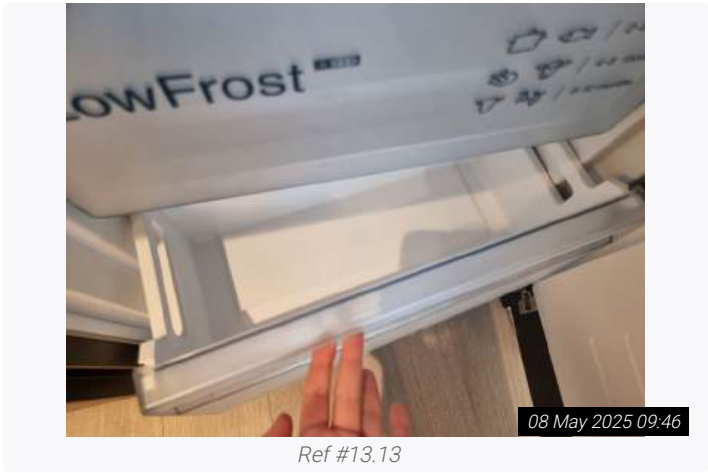
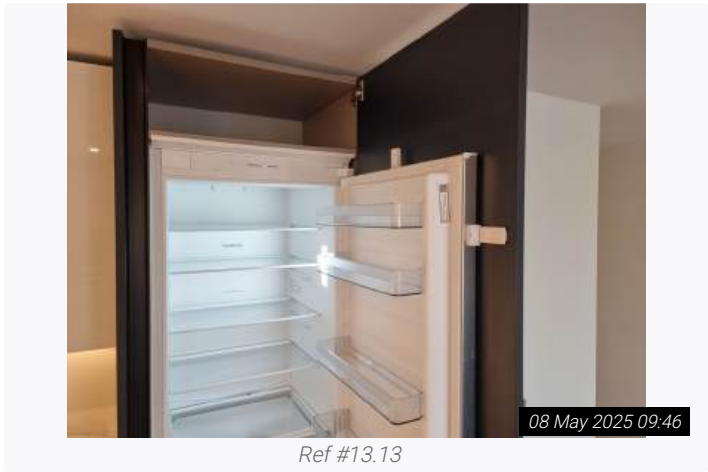
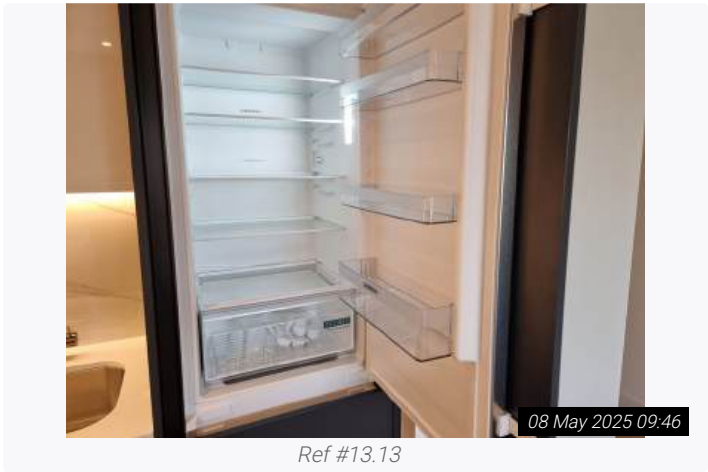
13. Open Plan Kitchen (Cont.)

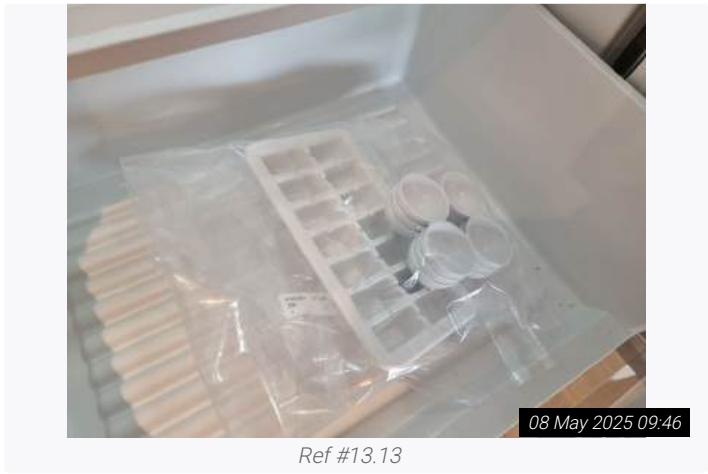
| Ref | Name | Description | Condition |

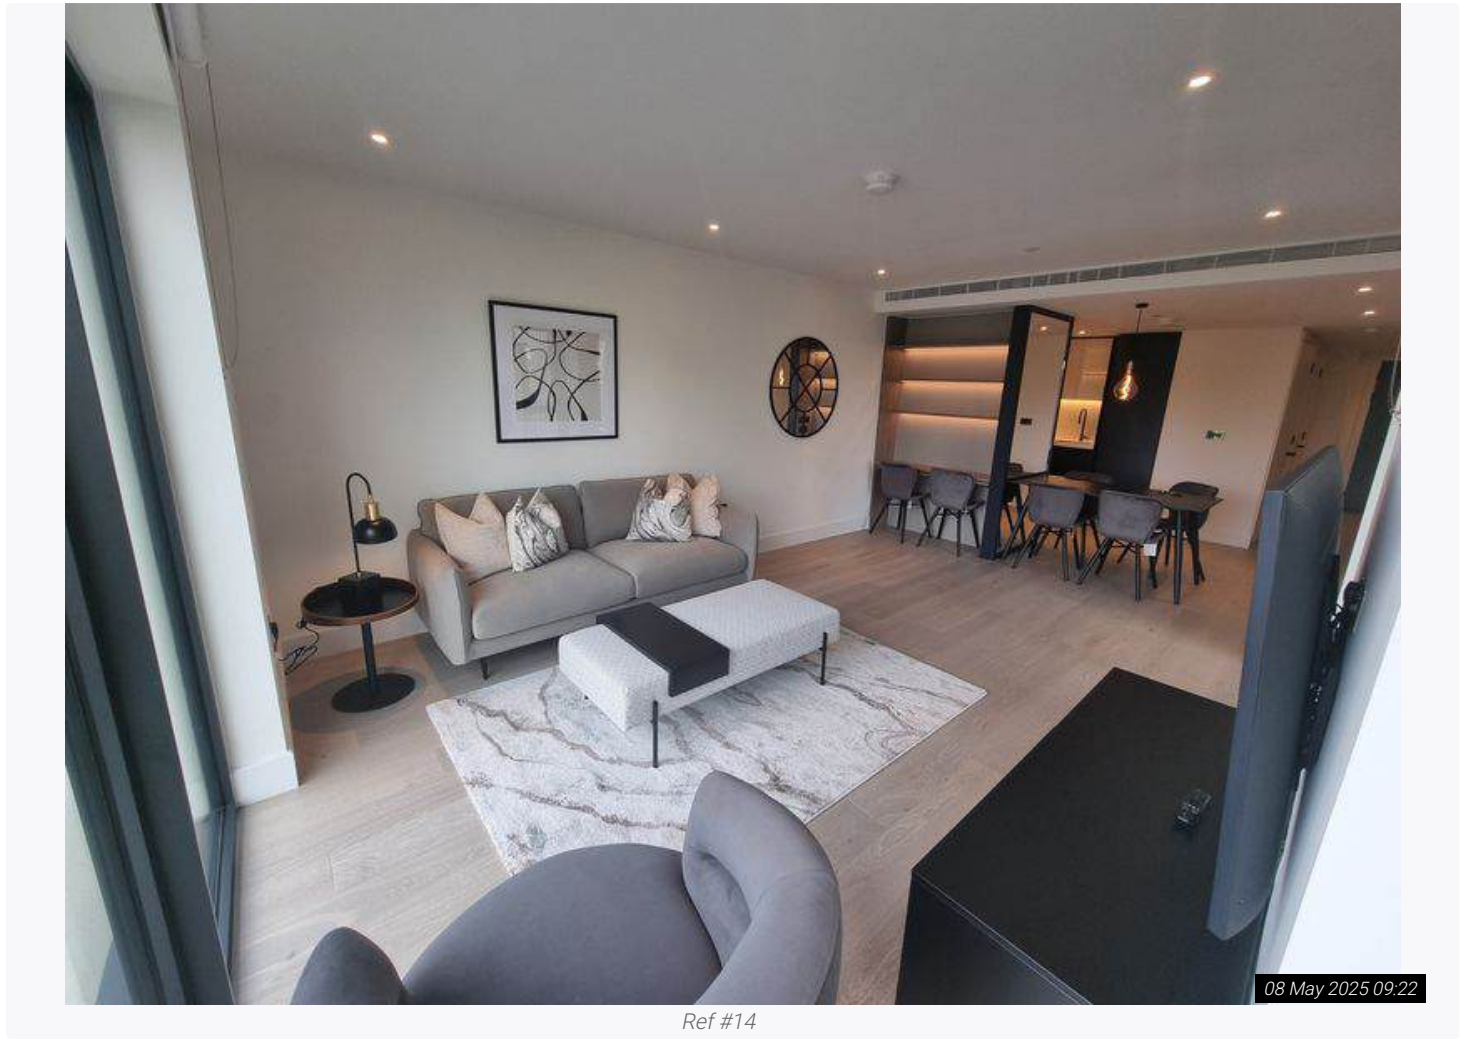
| Ref | Name | Description | Condition |

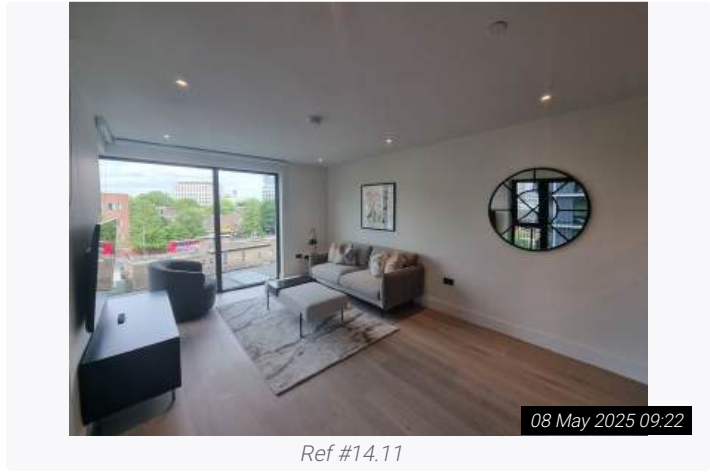
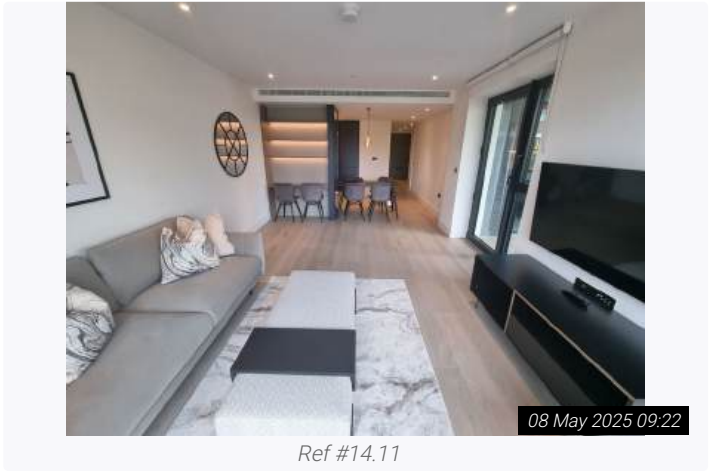
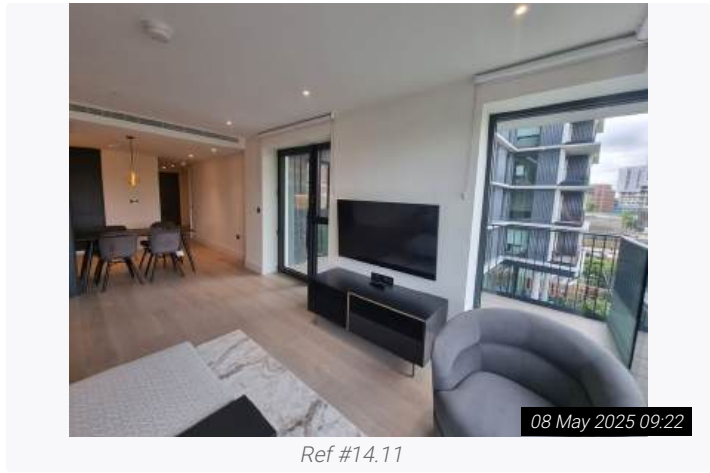
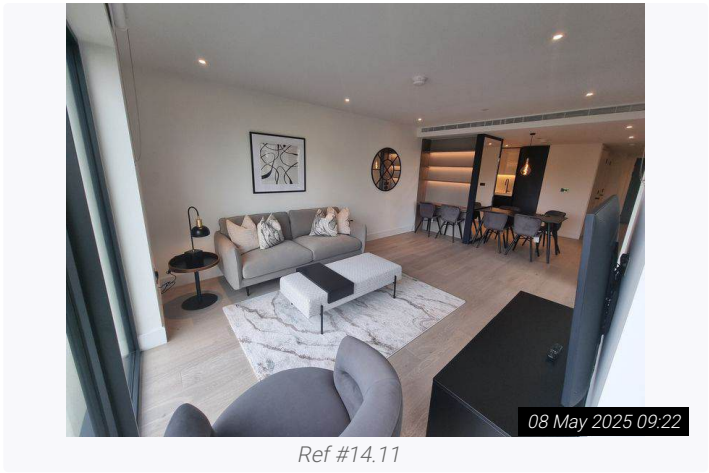
14. Reception (Cont.)

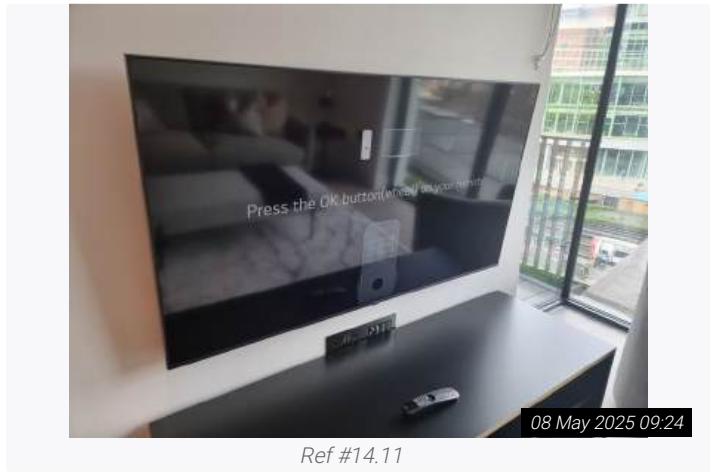
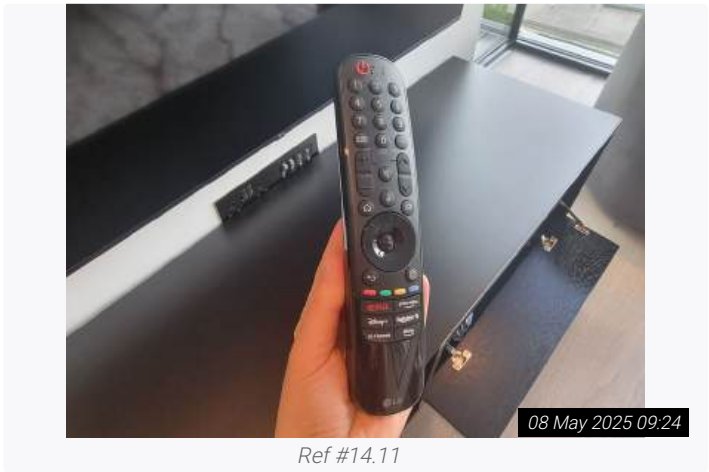
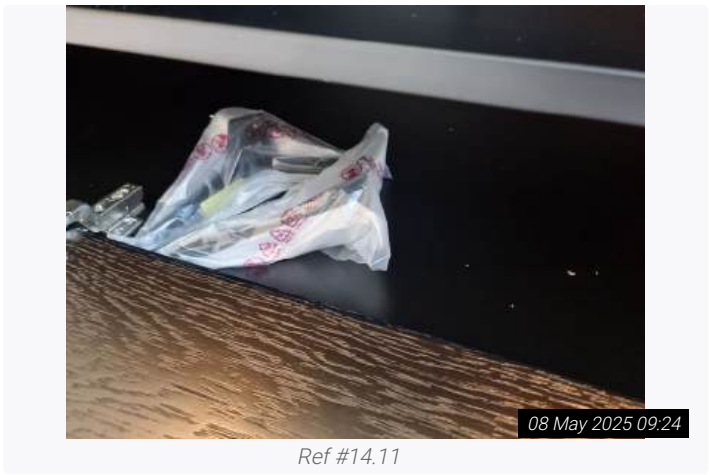
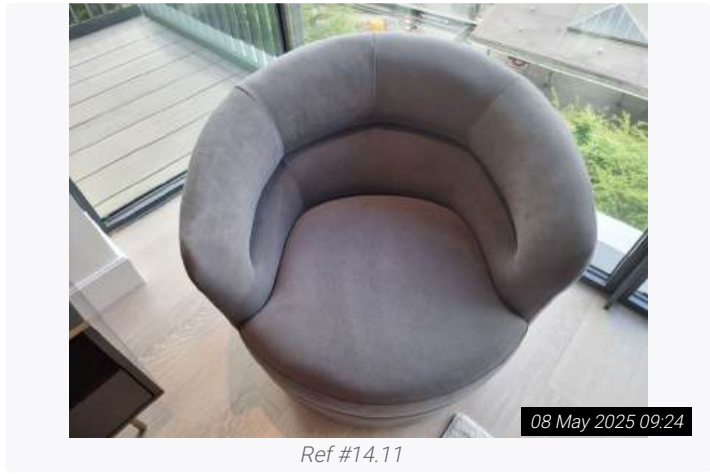
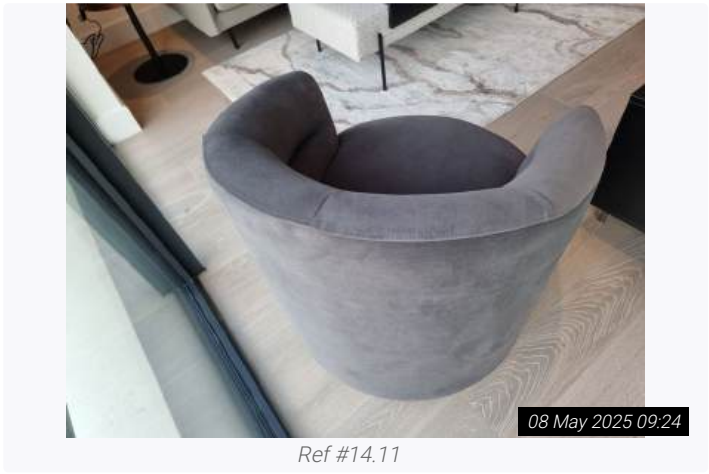
14. Reception (Cont.)

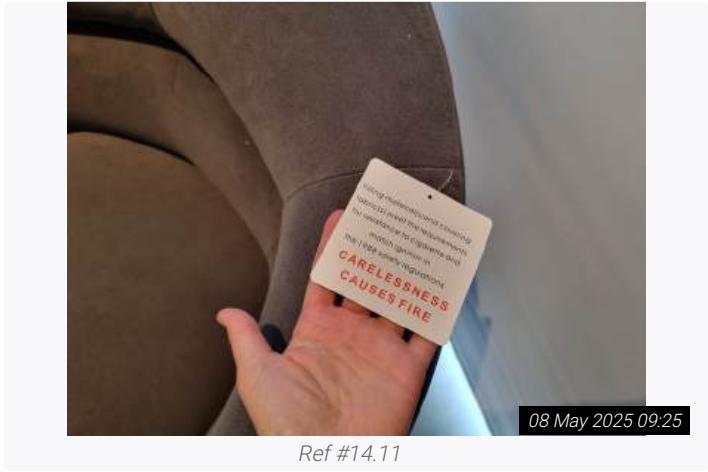
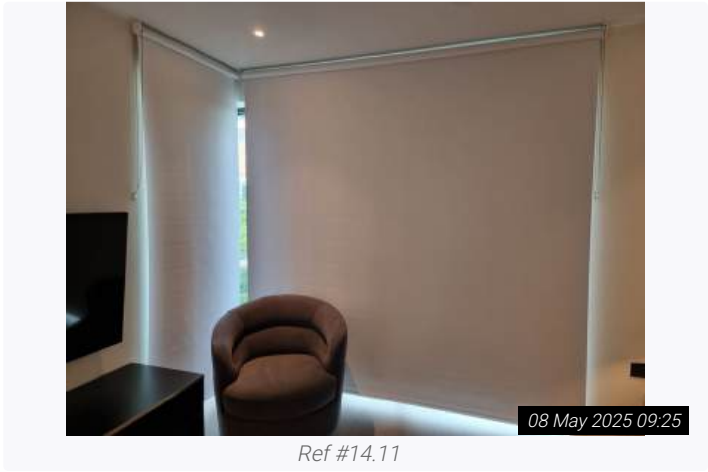
14. Reception (Cont.)

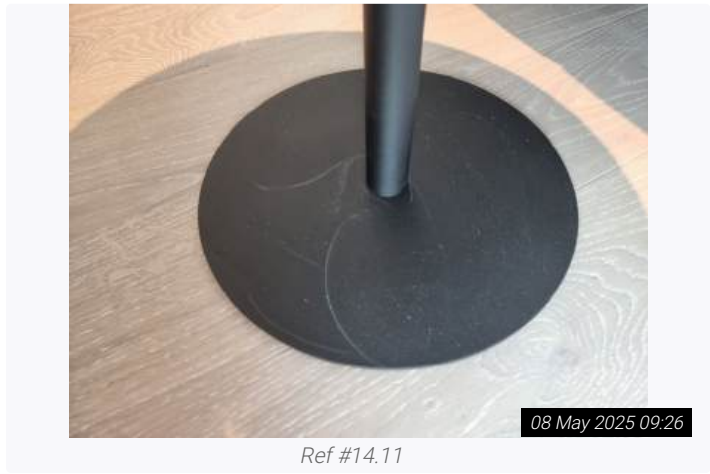
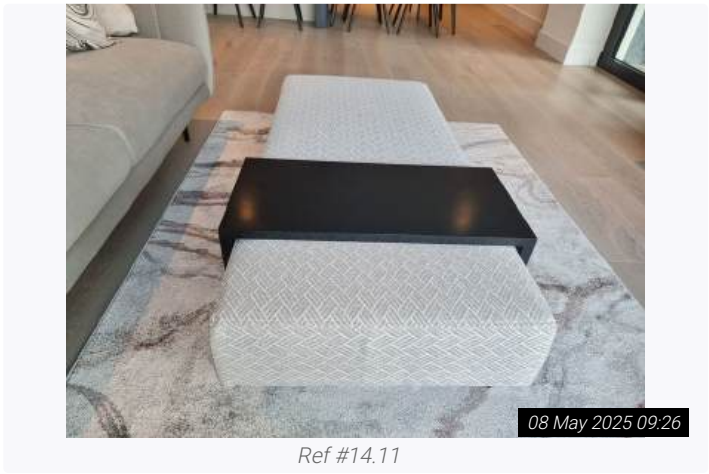
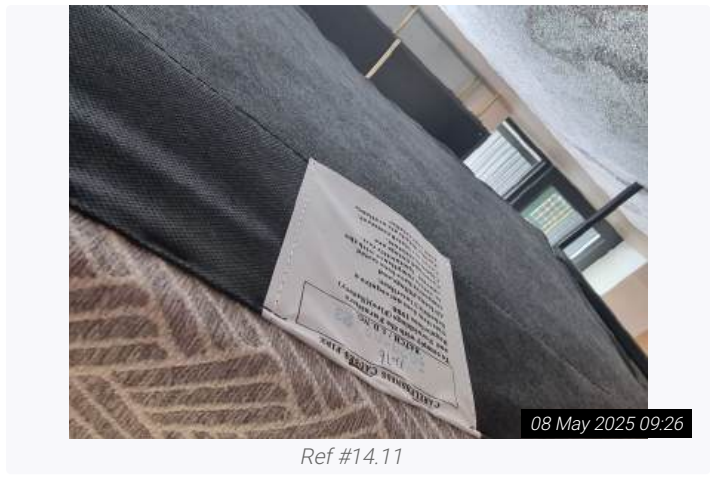
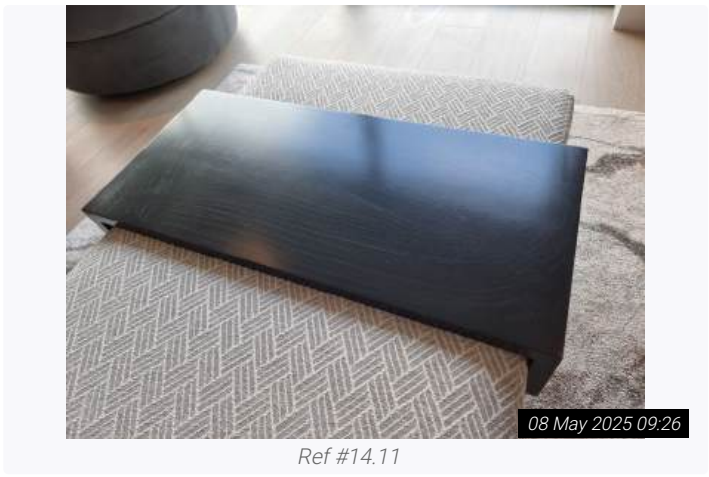
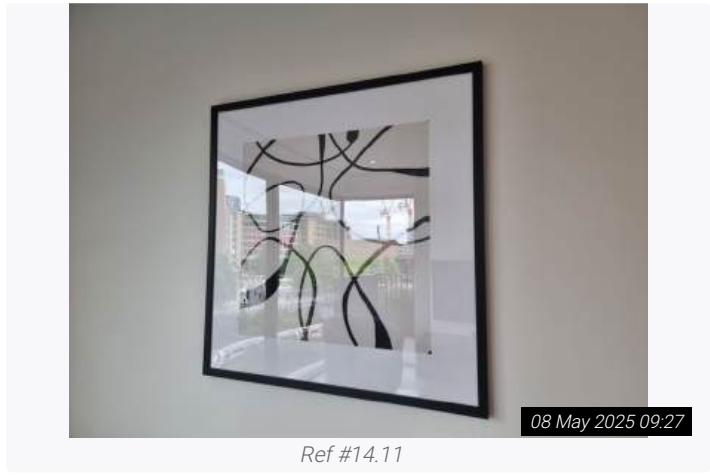
14. Reception (Cont.)

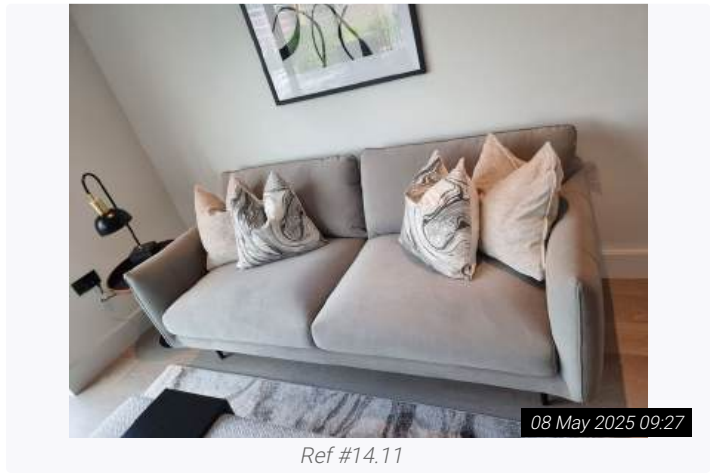
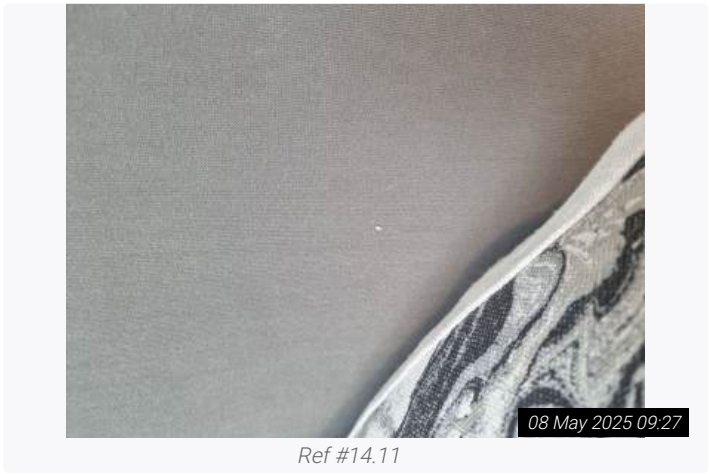
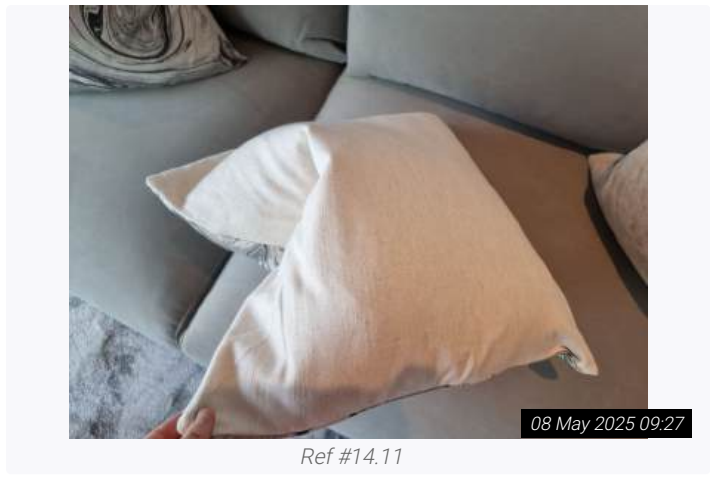
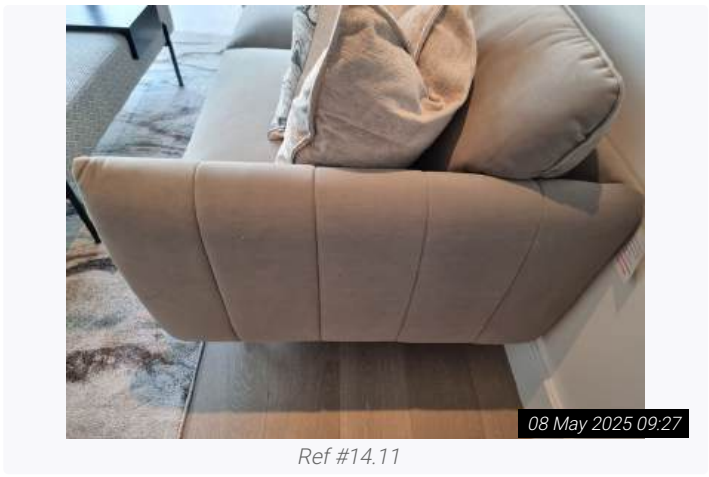
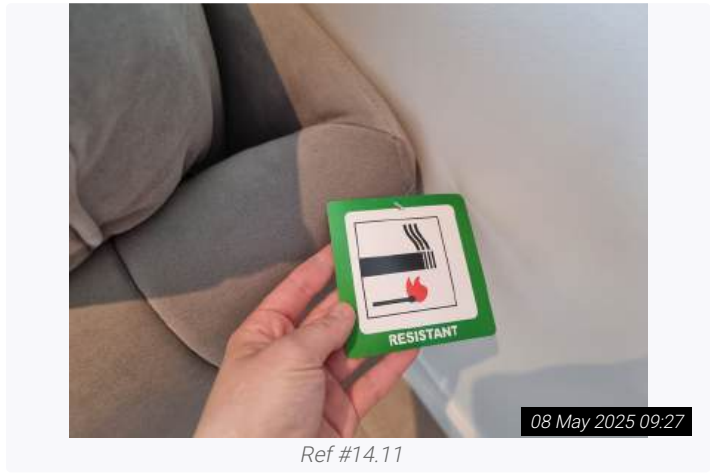
14. Reception (Cont.)

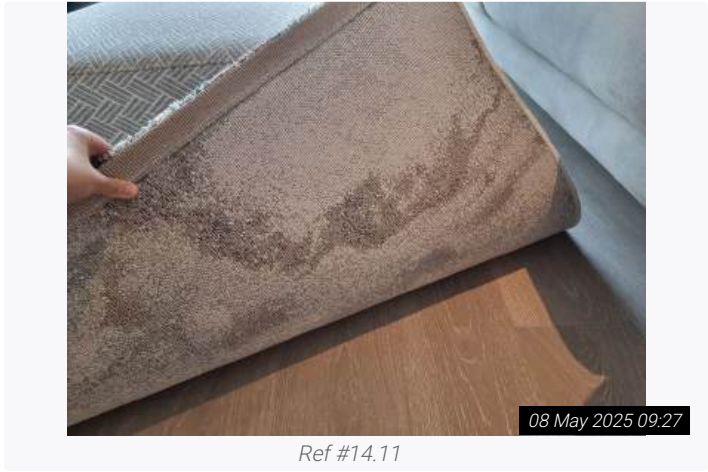
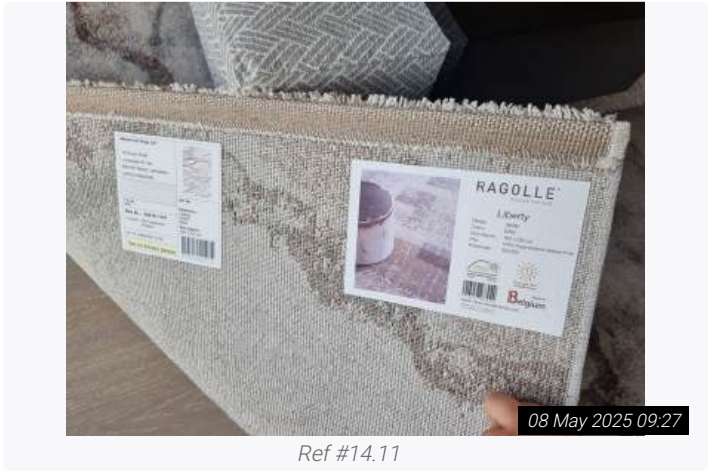
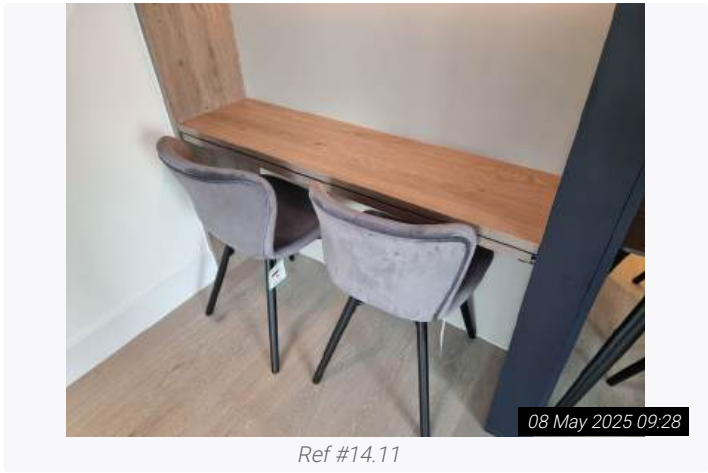
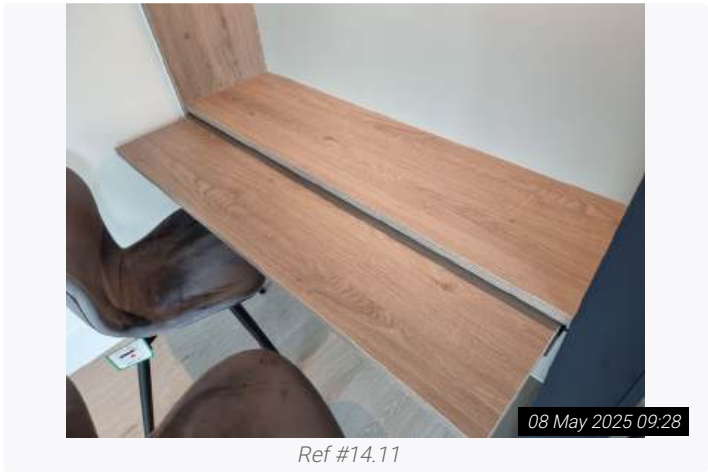
14. Reception (Cont.)

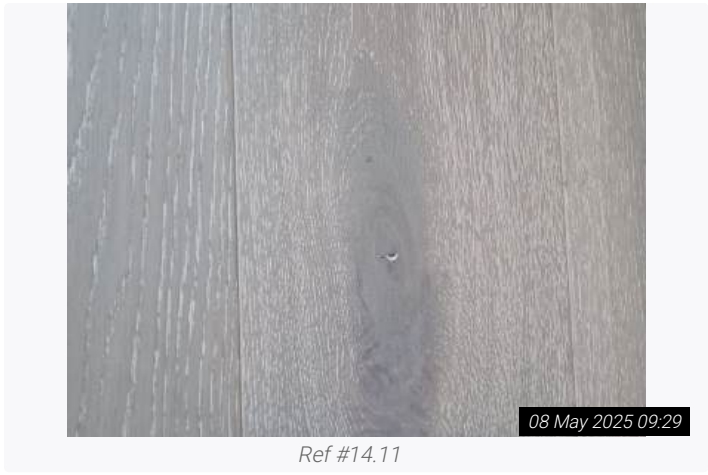
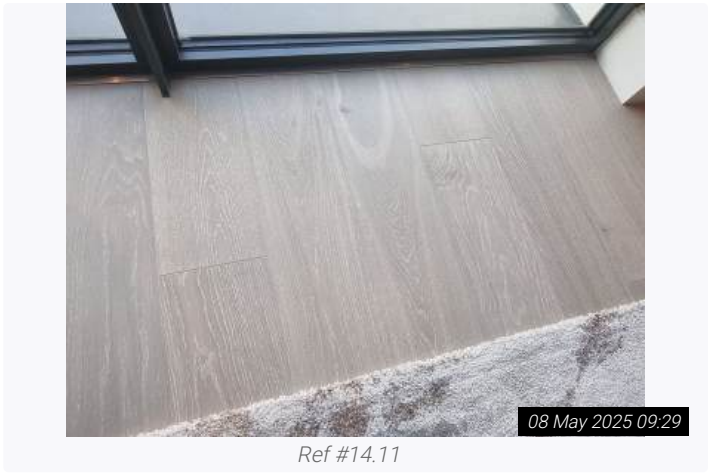
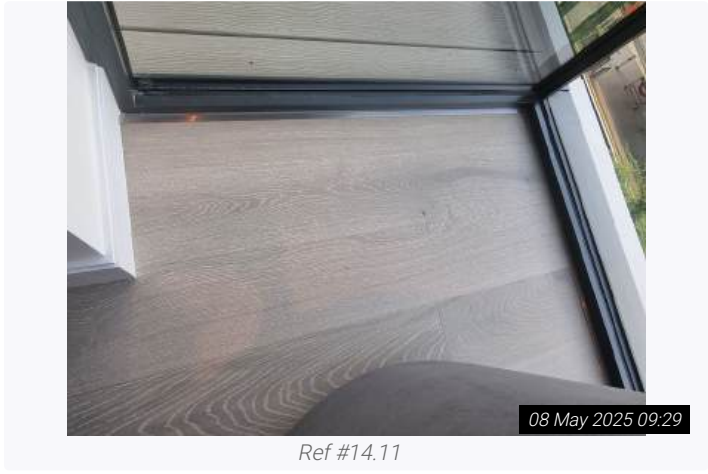
14. Reception (Cont.)

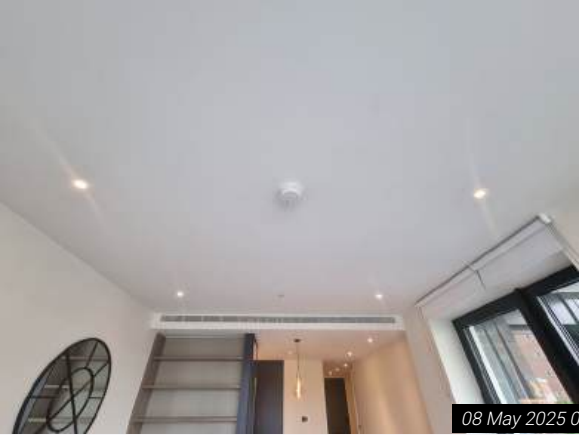
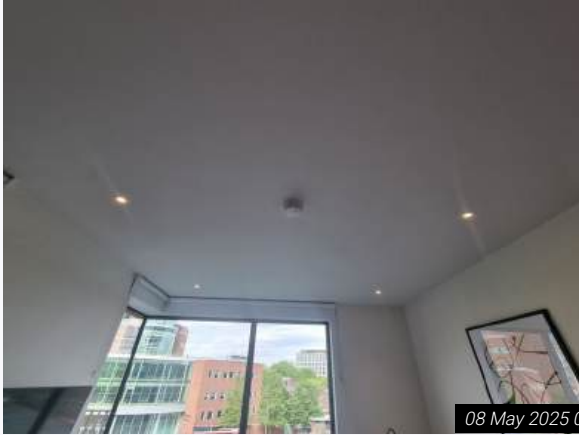
| Ref | Name | Description | Condition |
|---|---|---|---|
| <div><div><p>08 May 2025 09:29</p><p>Ref #14.11</p></div><div><p>08 May 2025 09:29</p><p>Ref #14.11</p></div></div> | | | |

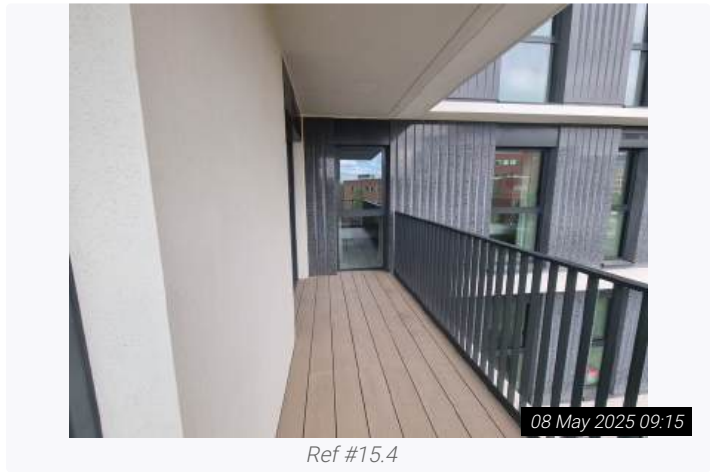
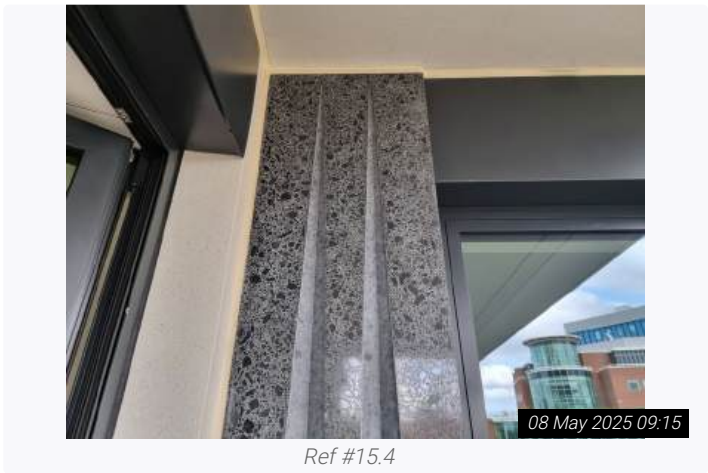
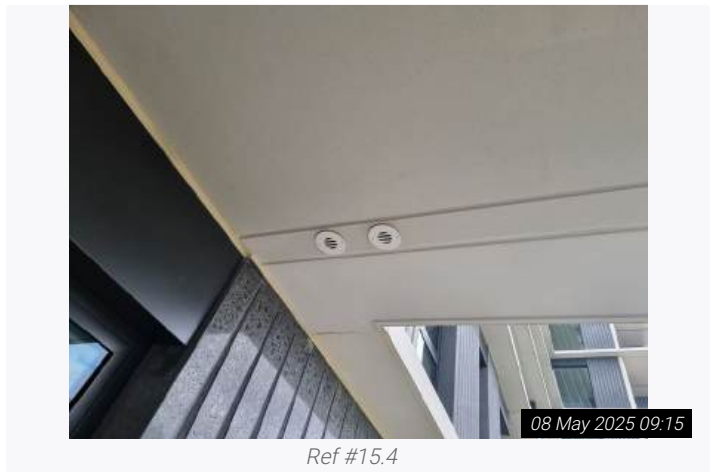
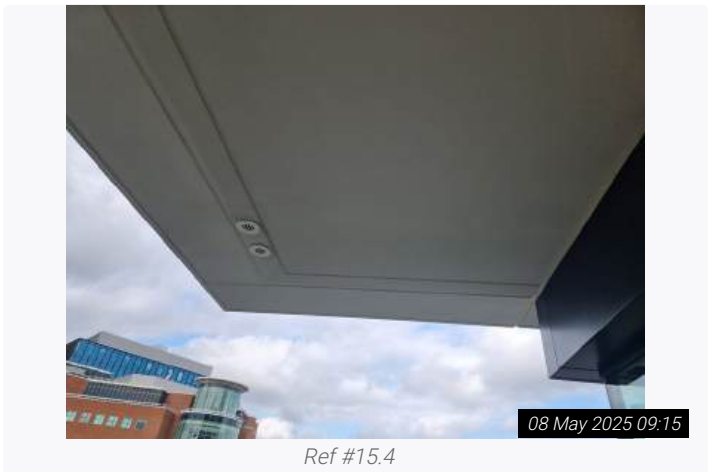
| Ref | Name | Description | Condition |
